Appendix H. Historical Resources Reports

**HISTORICAL RESOURCES IMPACT ASSESSMENT
SOUTHEAST LRT ALIGNMENT
IN LSD 15-33-52-24-W4M
IN THE CITY OF EDMONTON**

FINAL REPORT ARCHAEOLOGY PERMIT 2011-249

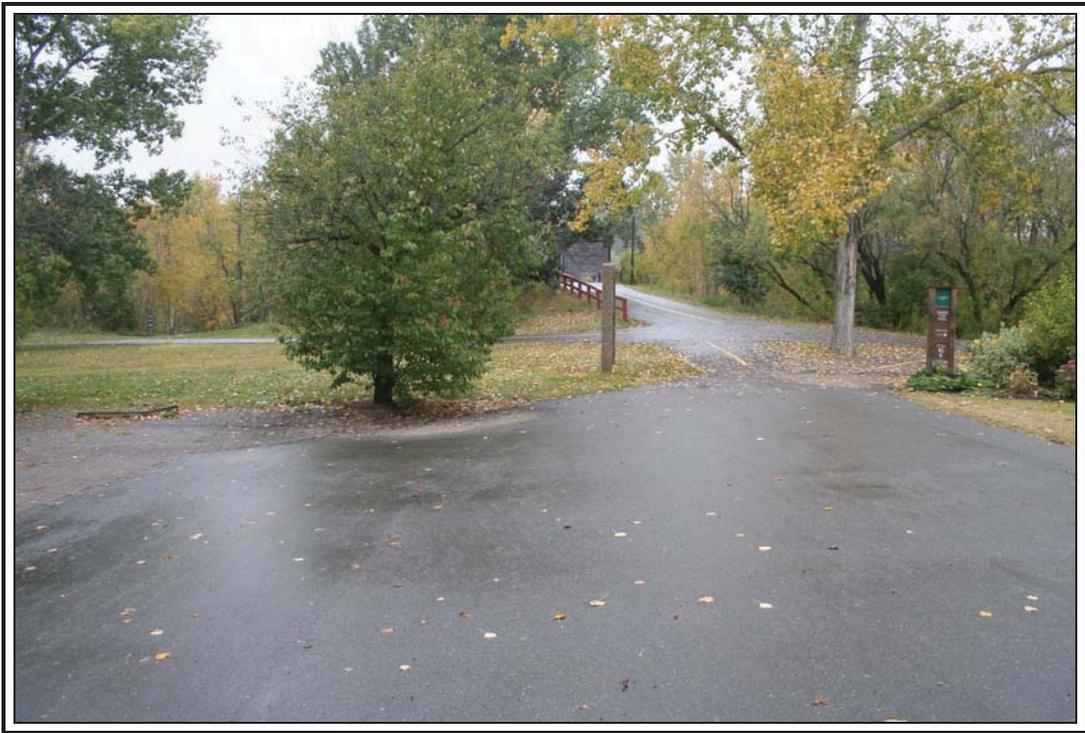
Photograph 1. View to the north across a paved area leading to the footbridge over the North Saskatchewan River.

The area surveyed consists of a strip of land approximately 100 metres long by 25 metres wide extending from the sidewalk at the south end of the footbridge over the North Saskatchewan River across a gully up to the edge of 98 Avenue (Photographs 1, 2, 3 and 4). The area at the northern end of the study area (south of the end of the sidewalk up to the gully) appeared a likely candidate for deep testing using a backhoe (Photographs 5, 6, and 7). Alberta One-Call identified a buried pipeline running along the edge of the gully (Photographs 7 and 8) and it was noted that a water line and an electric line run from the metal boxes seen in Photograph 4 to a park building to the west (Photograph 7). It appears that all or almost all of the 6 or so metre wide area on the top of the north bank of the gully was disturbed by the excavations for these infrastructure installations, so no deep testing or shovel testing was undertaken between the north edge of the gully and the paved sidewalk to the north.

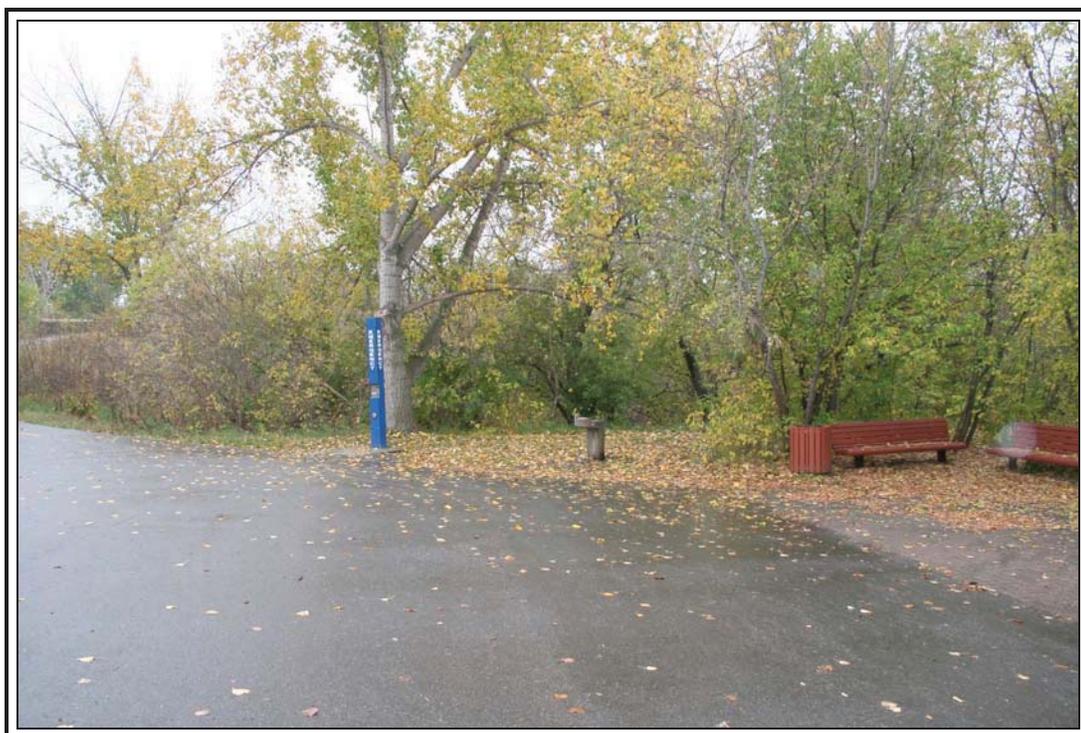
Photograph 2. View to the south showing the location of a small gully immediately beyond the large tree and the small flat area between the paved area and the edge of the gully.

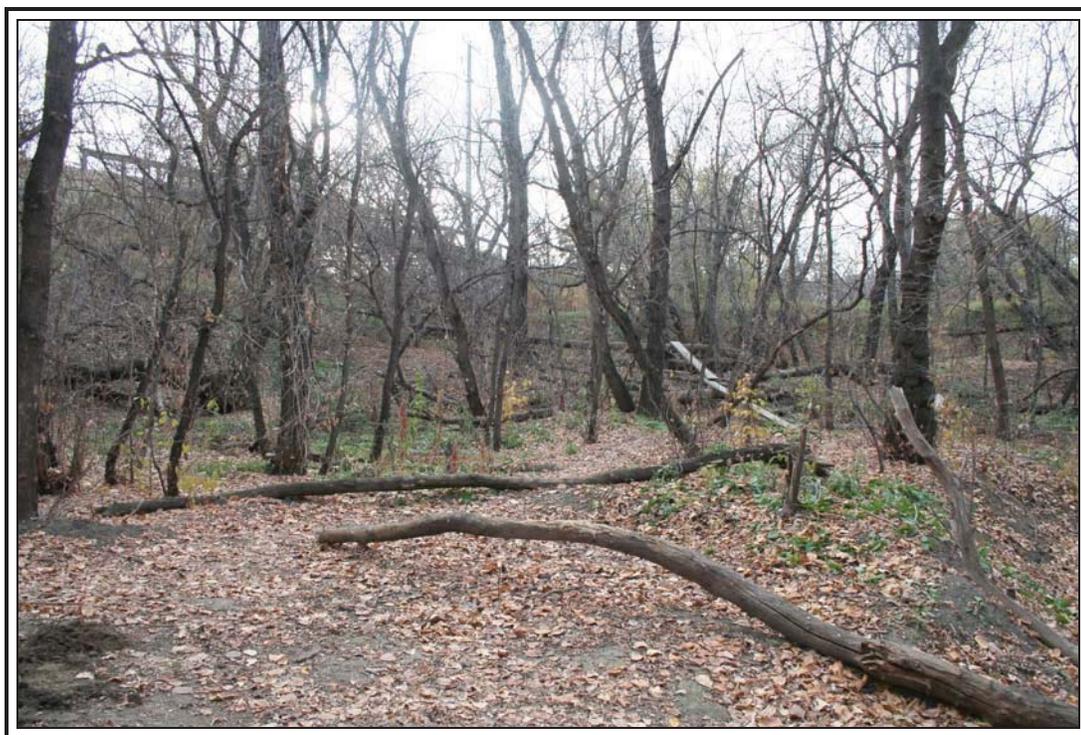
Photograph 3. View to the south-southeast across the gully bottom towards 98 Avenue.

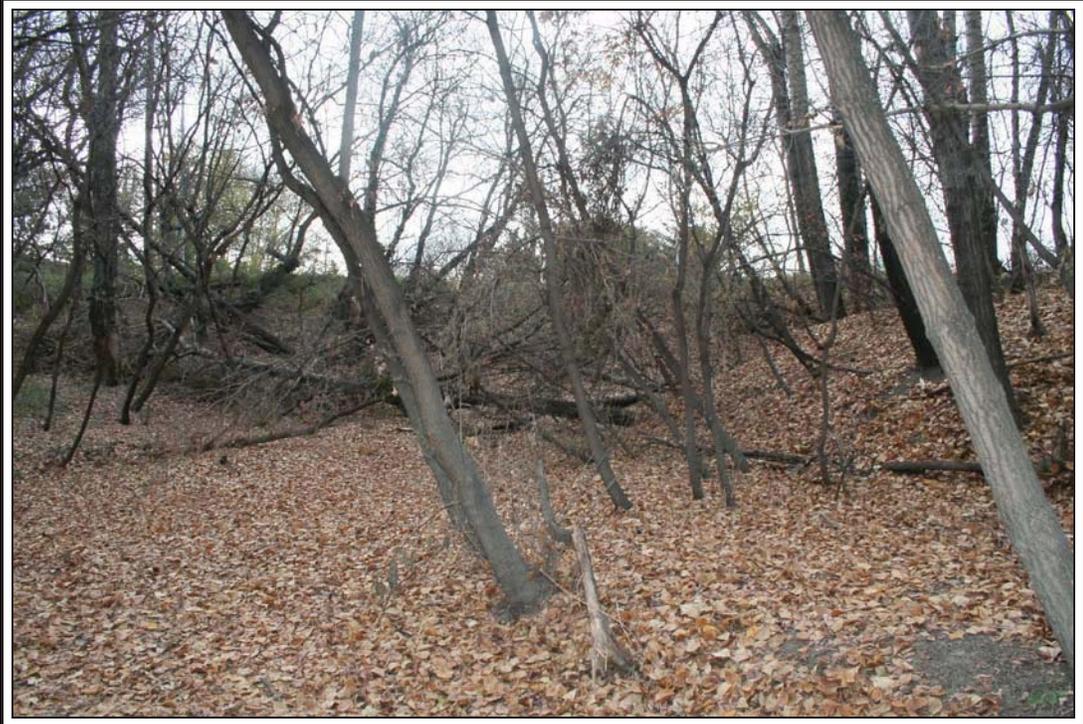
Photograph 4. View to the south showing the side-slope up to the sidewalk which runs along 98 Avenue.

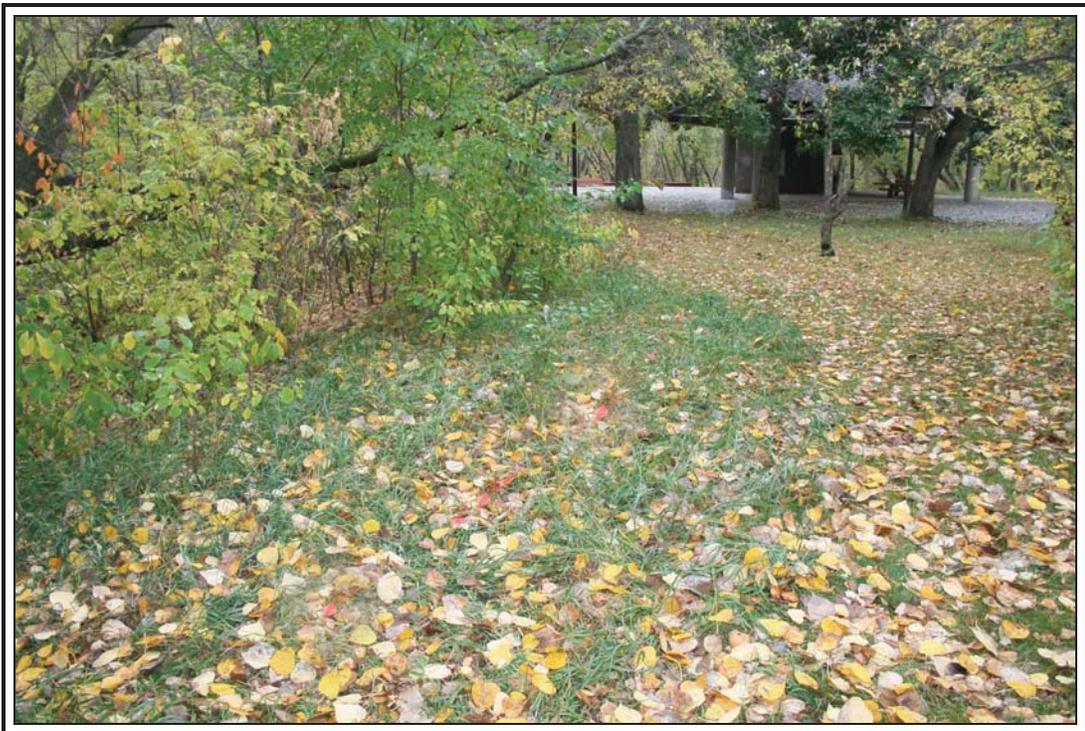
Photograph 7. View to the west showing the park building that the water line and electrical lines run towards from the emergency post and the water fountain. The intermittent orange line on the grass marks the buried pipeline identified by Alberta One-Call.

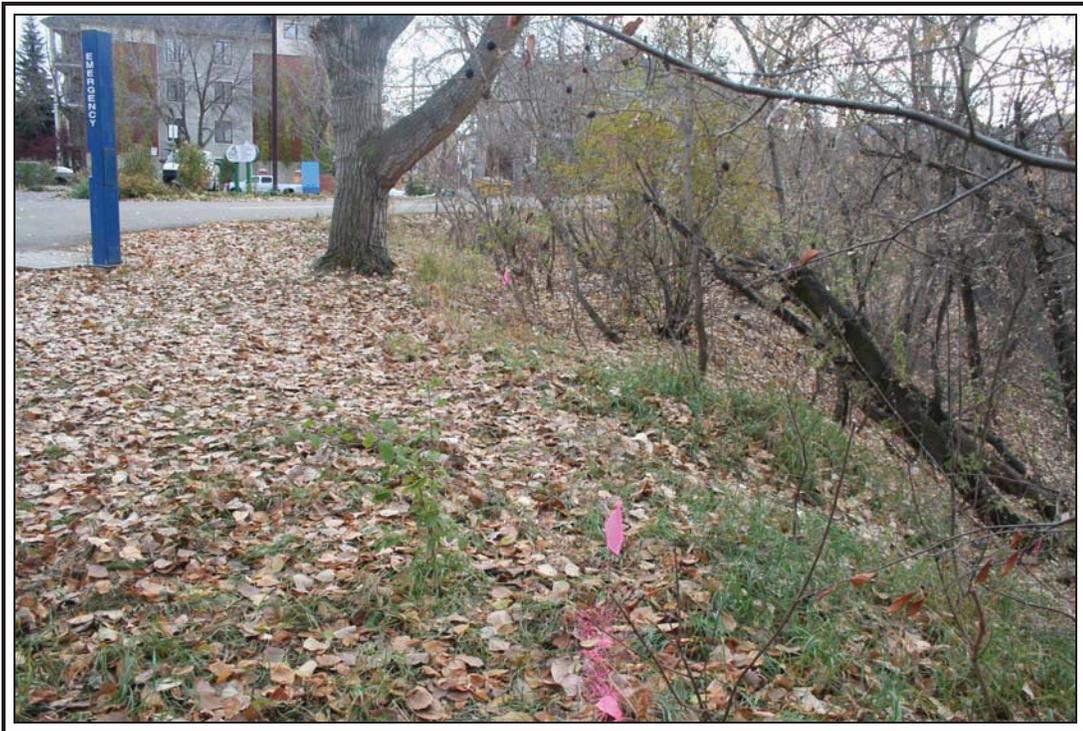
Photograph 8. View to the east showing the location of the buried pipeline that was flagged by Alberta One-Call along the edge of the gully.

On the northern downslope into the gully just below the buried pipeline that Alberta One-Call had flagged were a number of cultural items extending half way down the slope. These items included a wire cable, a plastic (PVC) pipe, a metal gas line pipe, concrete, and a piece of sheet metal that may have been a stove part (Photographs 9 and 10). The cable, the plastic pipe, and the gas line pipe were embedded in the side of the gully and when pulled upon they did not budge, which suggested that they were deeply embedded.

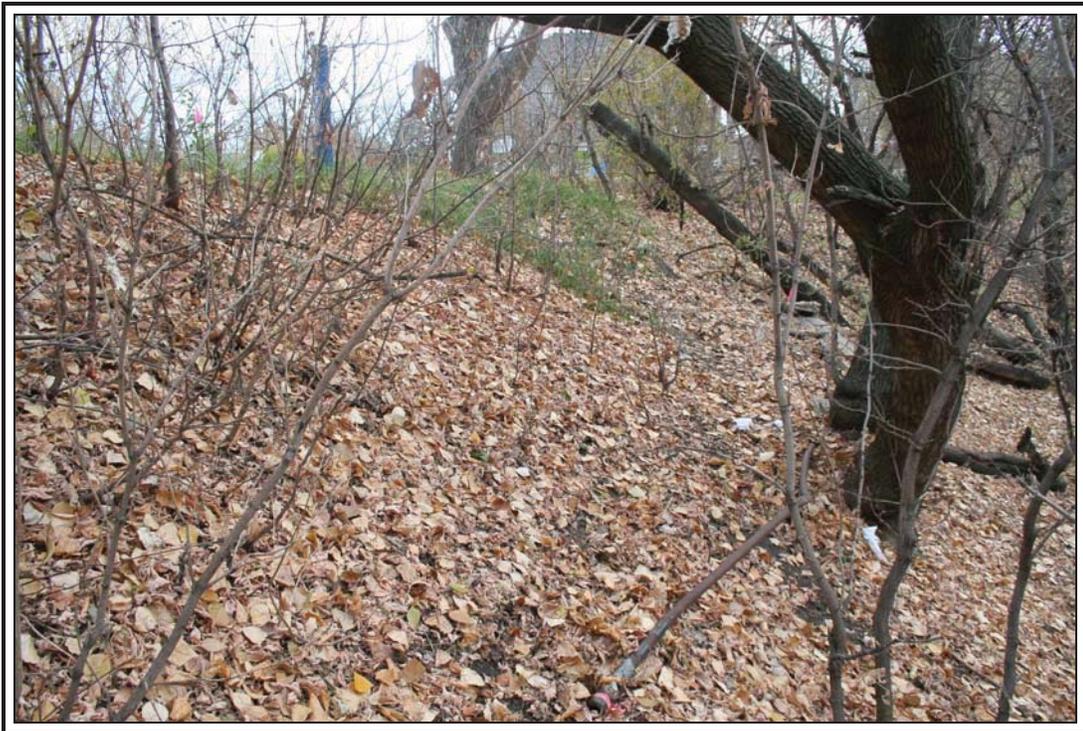
Photograph 9. View to the northeast showing the gully's northern downslope. A metal gasoline pipe is visible at the bottom centre of the photograph.

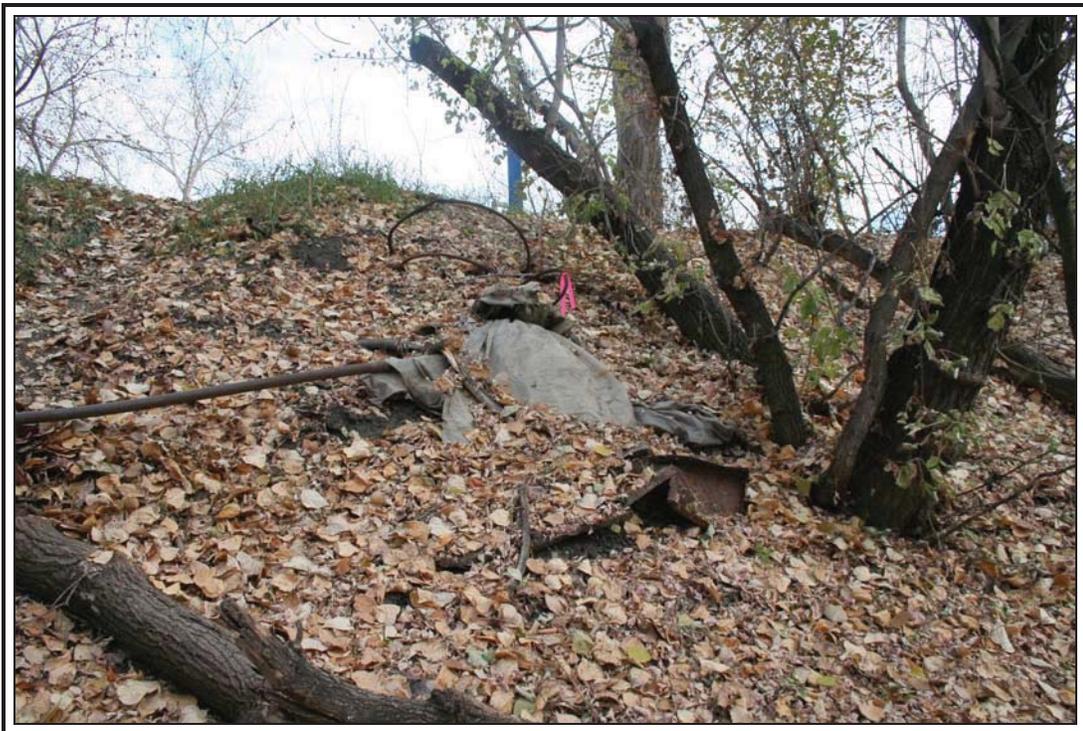
Photograph 10. View to the north showing the modern cultural materials on the gully's northern downslope, some of which were embedded in the side of the gully.

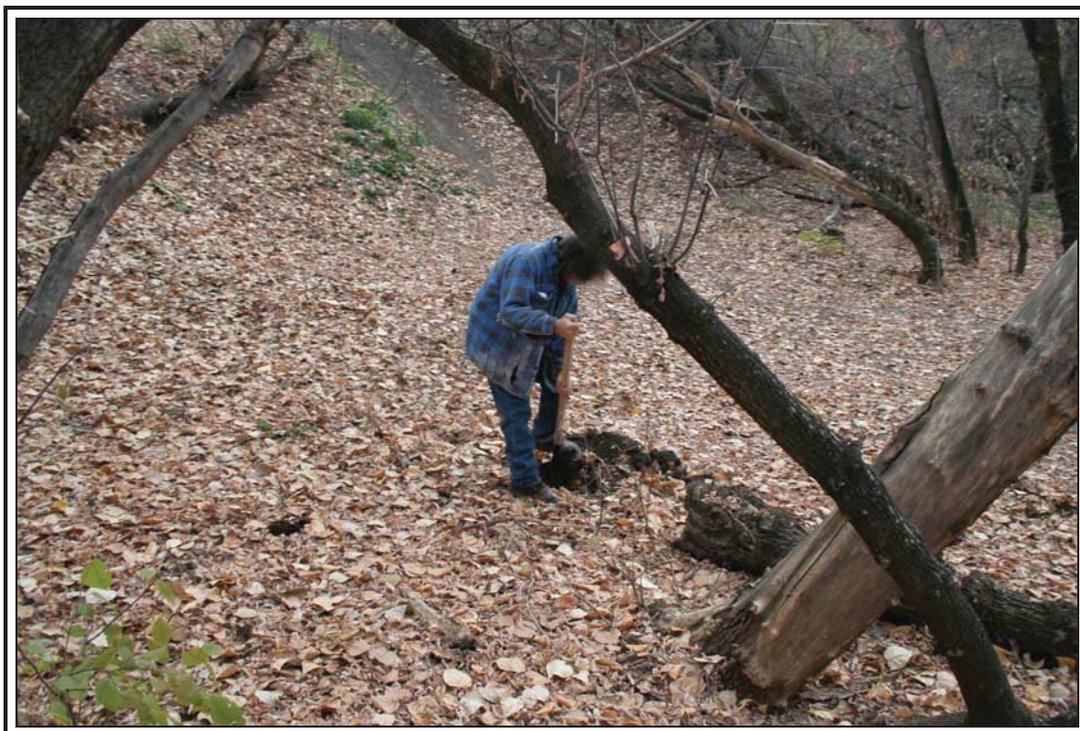
Photograph 14. Photograph showing one of the shovel test locations on one of the flat benches within the gully.

There were a number of flat benches within the gully that extend from the bottom of the sideslope of the fill used to elevate a footbridge over 98th Avenue on the north edge of the study area. Fourteen shovel tests were placed on all of these flat benches and three shovel tests were placed on the bottom of the gully (Photographs 14 and 15). The shovel tests revealed a medium gray silt to depth (Photograph 16). No rocks, buried soils, stratigraphic layers, or cultural items were found in any of the shovel tests.

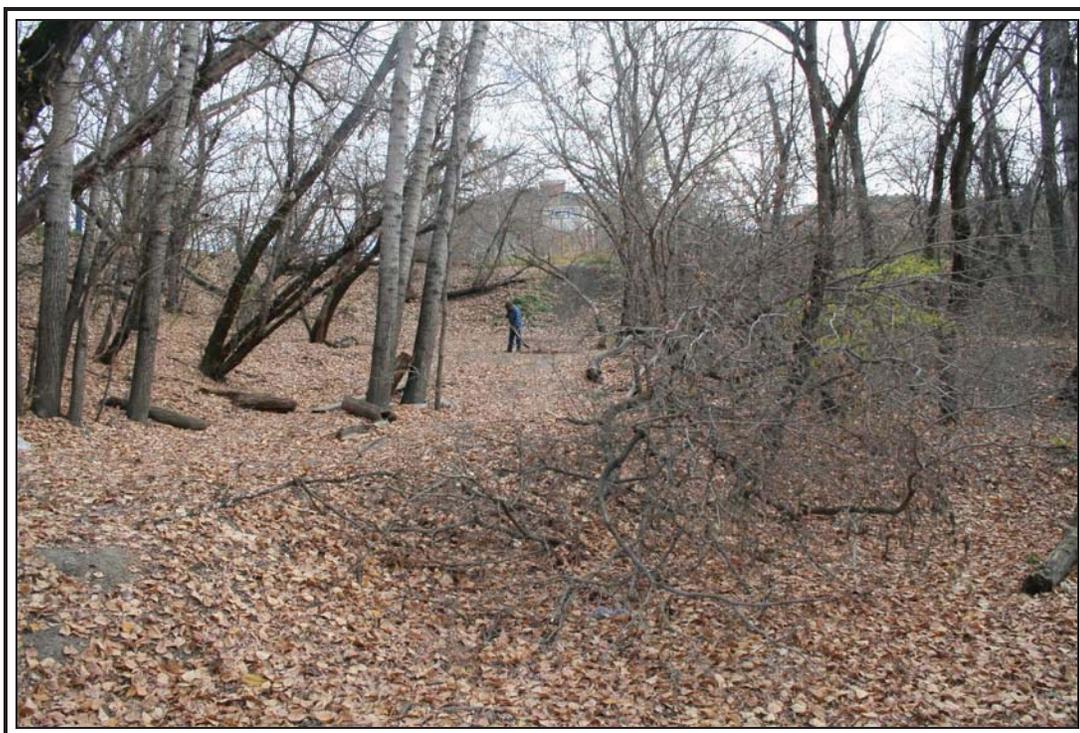
Photograph 15. Photograph showing one of the shovel test locations on a flat bench near the southern side of the gully.

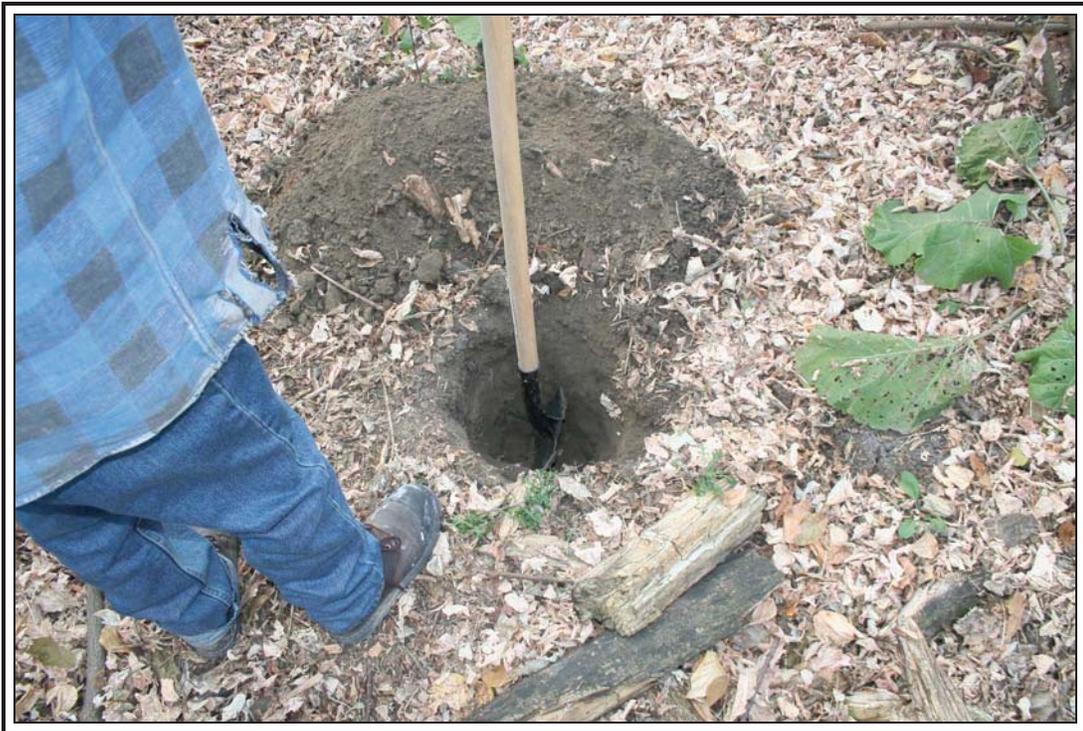
Photograph 16. Photograph showing the silty matrix found in the shovel tests within the gully.

Besides the modern cultural items found in the study area no significant historic cultural items and no palaeontological materials, stratified layers, or buried soils were found in the shovel tests, on the ground surface, or in existing exposures. The lack of significant historic cultural materials, stratified layers, buried soils, or palaeontological artifacts in the study area suggests that no further concern for historical resources is warranted for this project area.

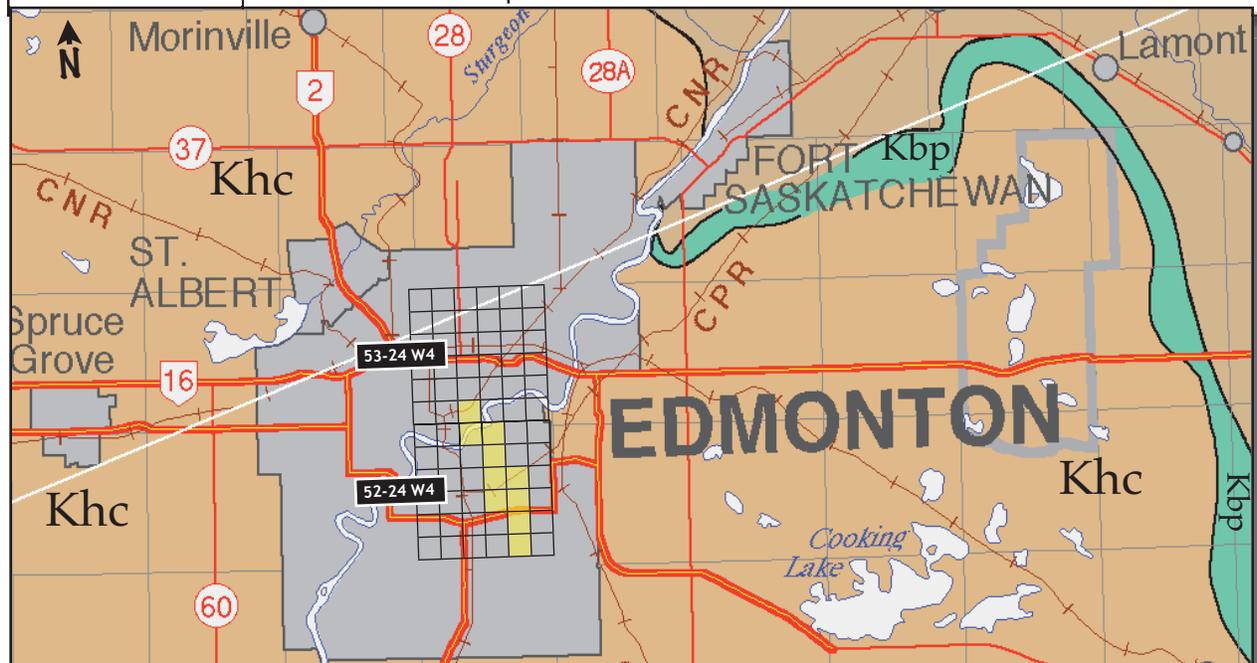
Figure 4. Portion of Geological Map of Alberta showing surficial bedrock. Proposed SE LRT located within Alberta Township Grid sections highlighted in yellow (■). Khc = Horseshoe Canyon Formation; Kbp = Bearpaw Formation. AB Geologic Survey 1999.

Beginning at the proposed ground-level Churchill station, an at-grade track system will be developed, running east-west down 102 Avenue. The LRT line will be excavated below-grade east of 96 Street and continue to slope downward along 102 Avenue until it enters the proposed LRT tunnel. The tunnel will run below 102 Avenue then turn south at 95 Street. The tunnel will continue south, below the existing city infrastructure, until the tunnel portal emerges, approximately midway down the bank of the north slope of the River Valley below 95 Street (Figs. 9-12). The proposed alignment of the tunnel below ground level suggests that a portion of the tunnel will be excavated through bedrock from the Horseshoe Canyon Formation (Figs. 4, 10).

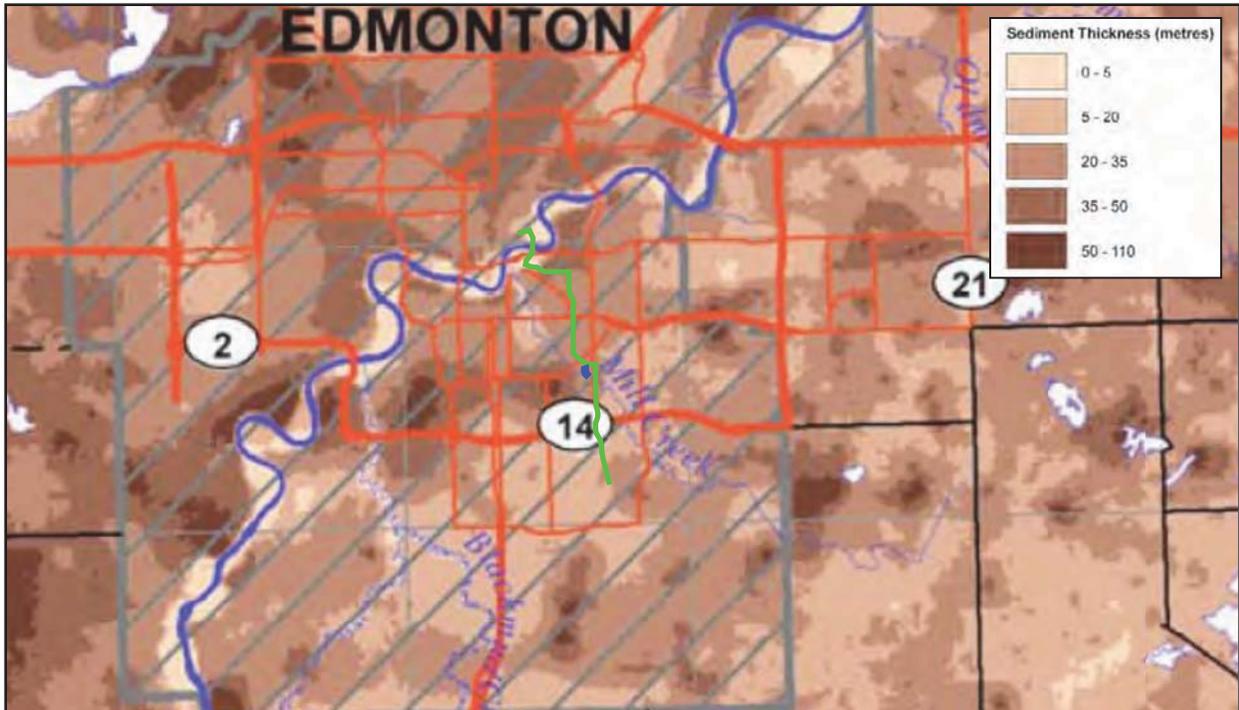
Figure 6. Drift thickness map showing proposed Southeast LRT route (—) and Davies Road optional alignment (—). Scale 1:500,000. Slattery & Barker 2010.

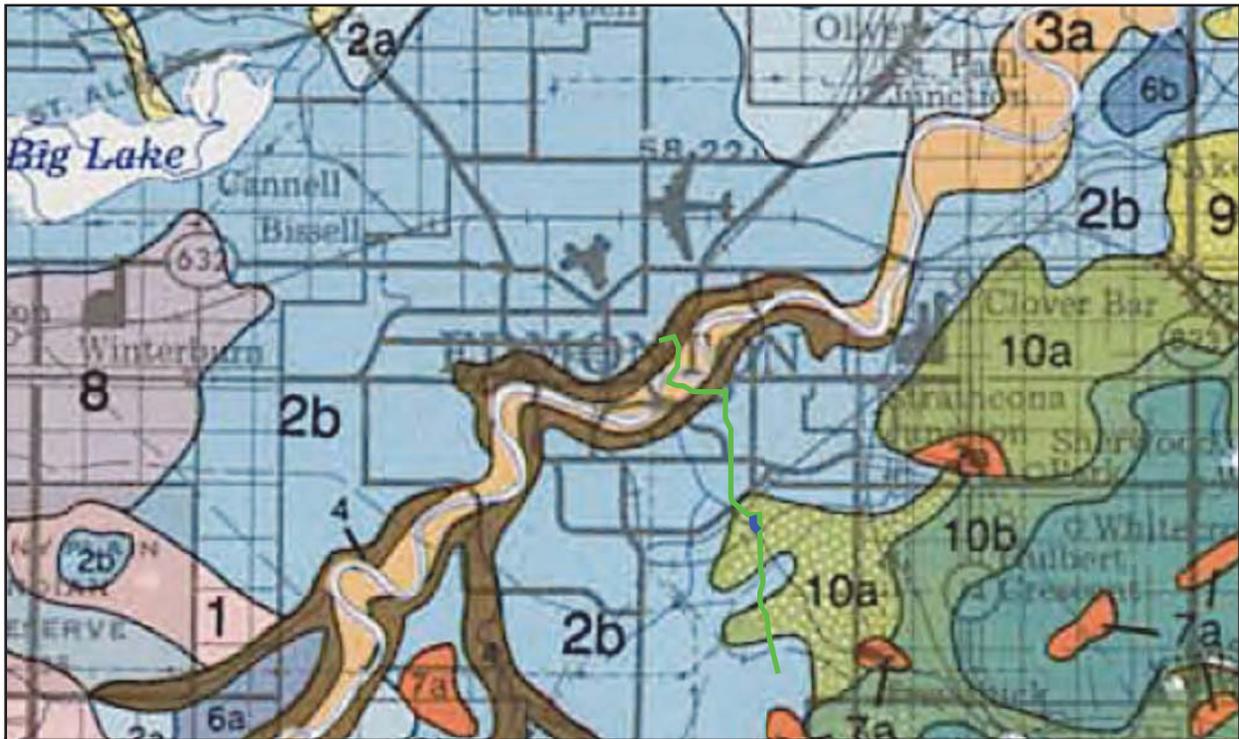
Figure 7. Quaternary geology map. Map legend: Lacustrine Deposit (2) - 2b = fine sediment (silt & clay); Fluvial Deposit (3) - 3a = coarse sediment (gravel, sand, & minor silt); Stream and Slopewash Eroded Deposit - 4 = exposed till and bedrock; Stagnation Moraine (10) - 10a = undulating topography with local relief generally less than 3 m. Shetson 1990.

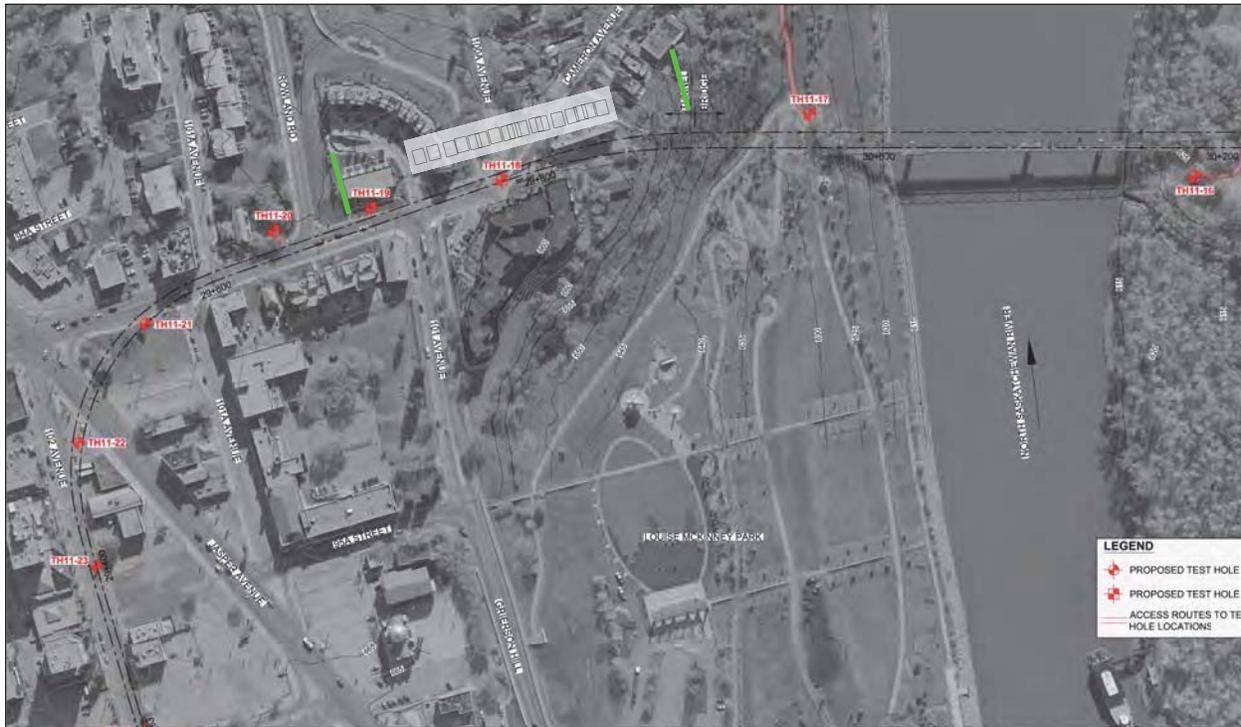
Figure 9. Geotechnical Test Hole Drilling Program. Green lines (—) bound section of proposed tunnel that will likely impact bedrock. Courtesy AECOM. Modified by Aeon.

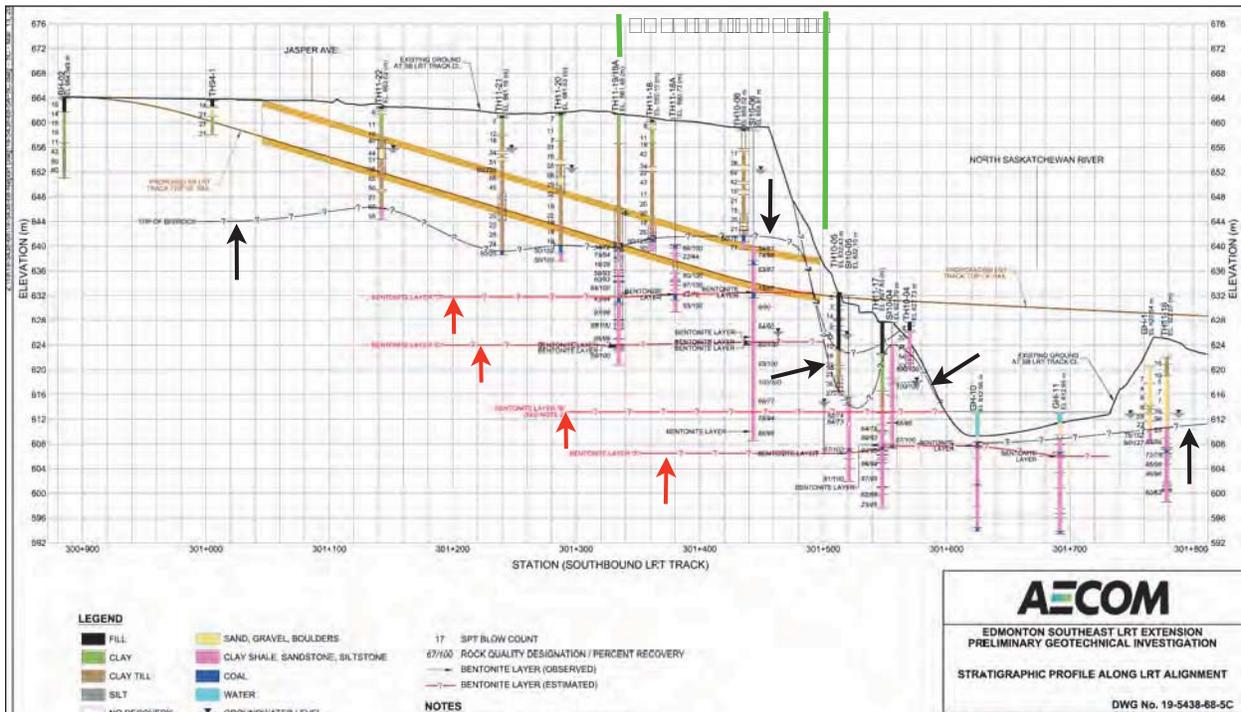
Figure 10. Stratigraphic profile along section of proposed LRT alignment. Drill/bore hole locations TH-11-16 to -22 shown. Note estimated top of bedrock (—?—)(→) and bentonite layers (—?—)(→). Green lines (—) bound section of proposed tunnel that will impact bedrock. Courtesy AECOM. Modified by Aeon.

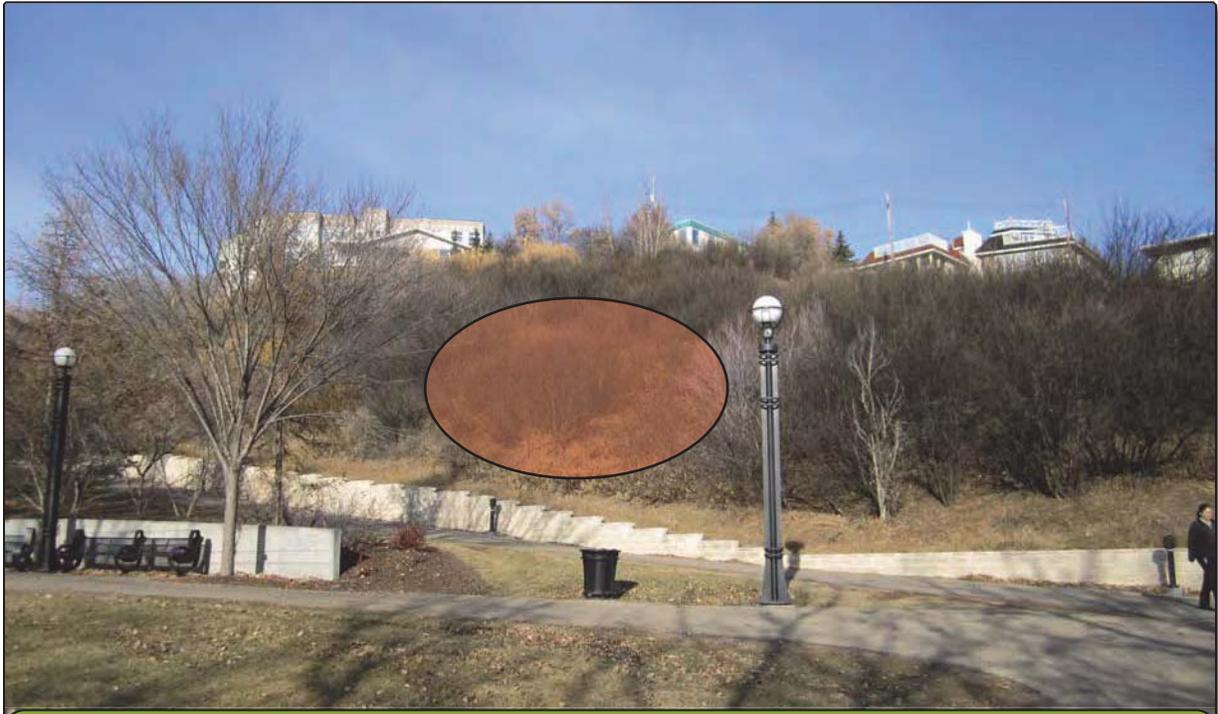
Figure 11. View facing north from pedestrian walkway on north bank of North Saskatchewan River Valley showing approximate LRT tunnel portal (●) placement.

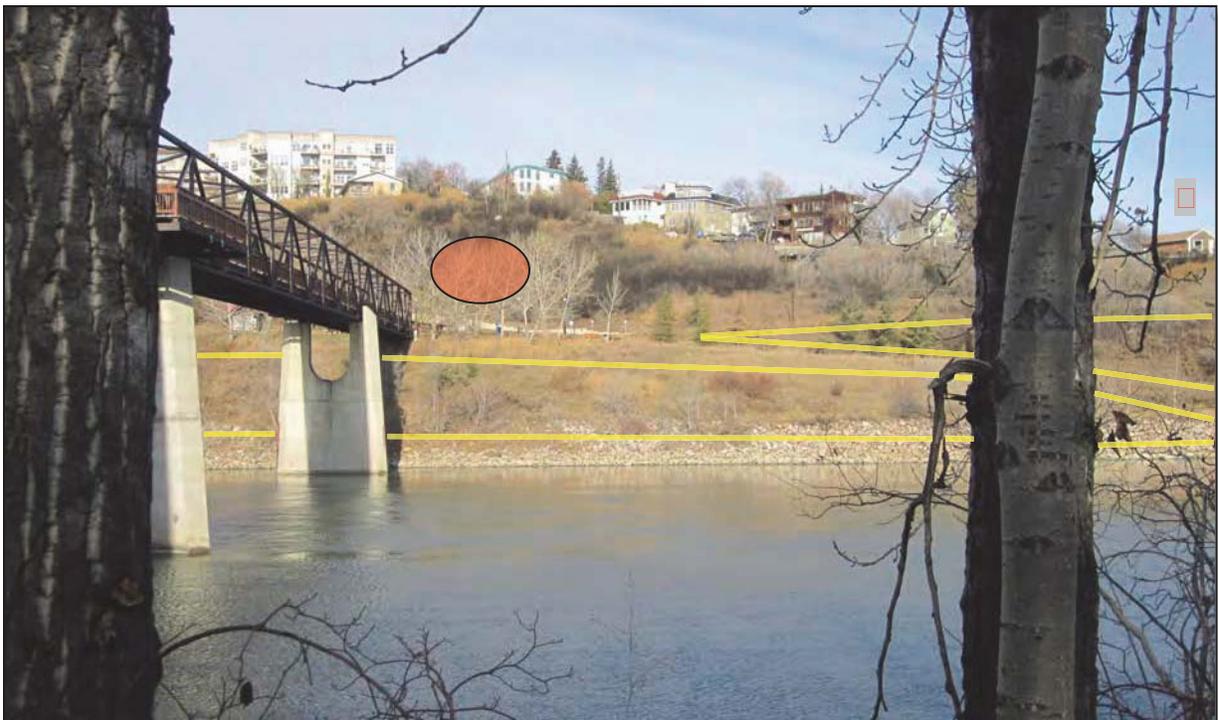
Figure 12. View facing north from south bank of North Saskatchewan River showing existing footbridge and approximate location of proposed LRT tunnel portal (●) on north valley slope. Note: bedrock likely near surface below thin vegetative/colluvial or landscaped cover (areas bounded by — lines). 1 = reference point (see house in Fig. 13)

Note: Along the north slope, bedrock is close to the surface at two areas likely slated for development during bridge construction: the tunnel portal and the north river bank (Figs. 10, 12). Paleontological monitoring has been previously suggested for the tunnel and tunnel portal development.

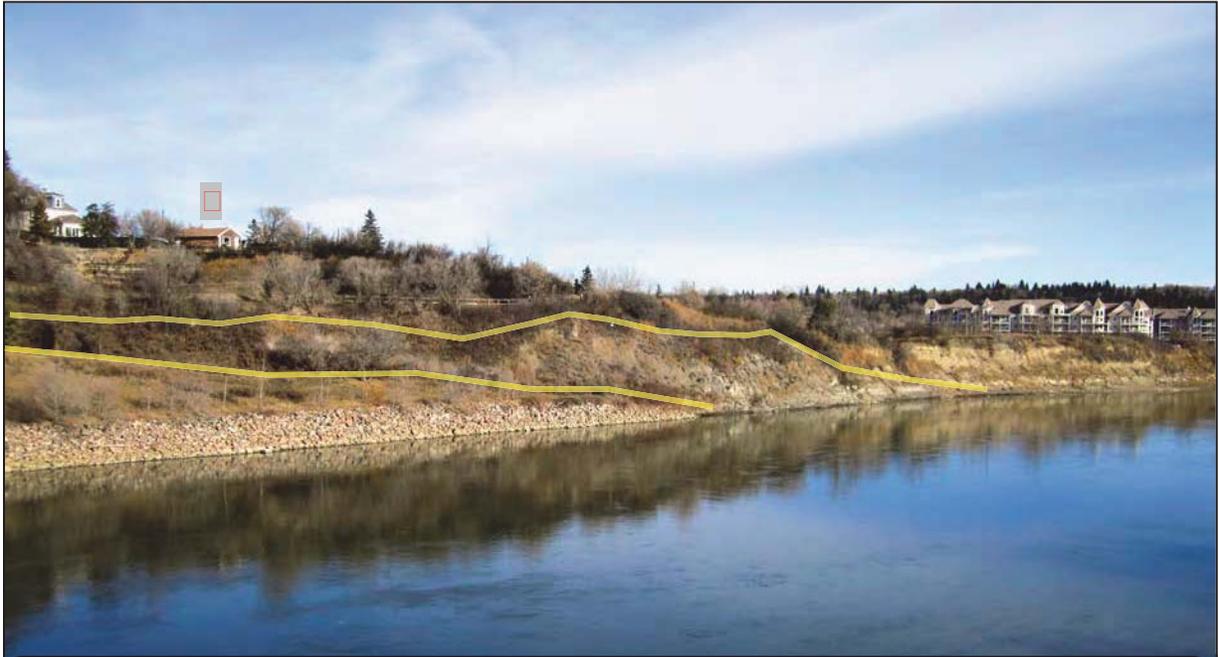
Figure 13. View facing northeast from footbridge of exposed bedrock face (bounded within — lines) along northside cutbank of North Saskatchewan River. 1 = reference point (see house in Fig. 12) proposed LRT alignment .

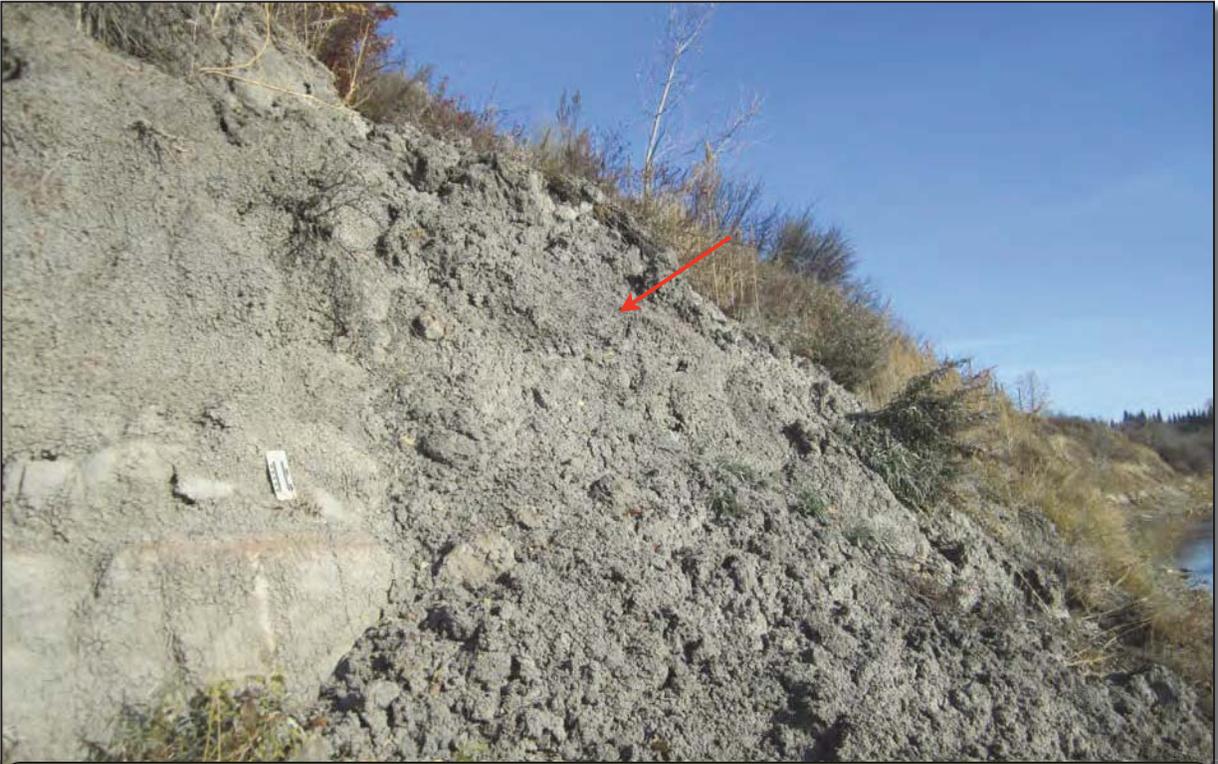
Figure 14. View looking east along north valley wall of North Saskatchewan River showing exposed bedrock from the Horseshoe Canyon Formation. Slide scar (→).

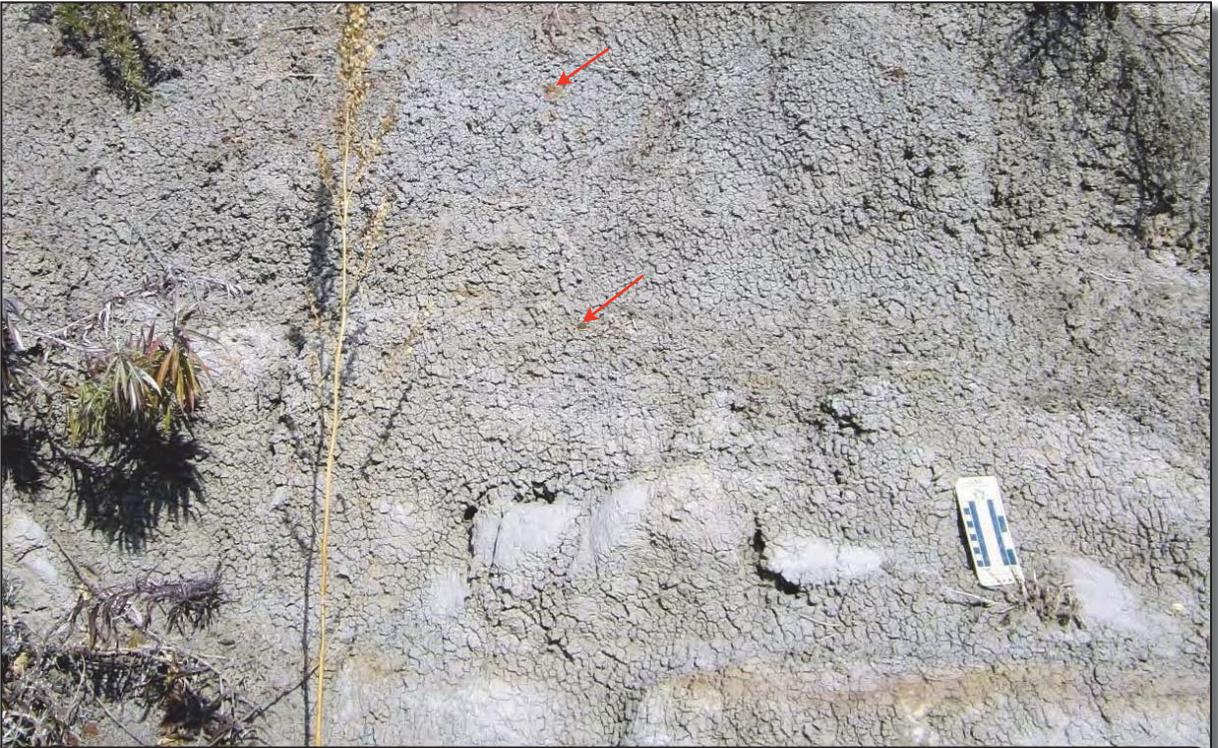
Figure 15. Close-up of weathered bedrock face in Fig. 14 showing interbedded layers of siltstone/mudstone, silty sandstone and ironstone fragments (→) in slopewash .

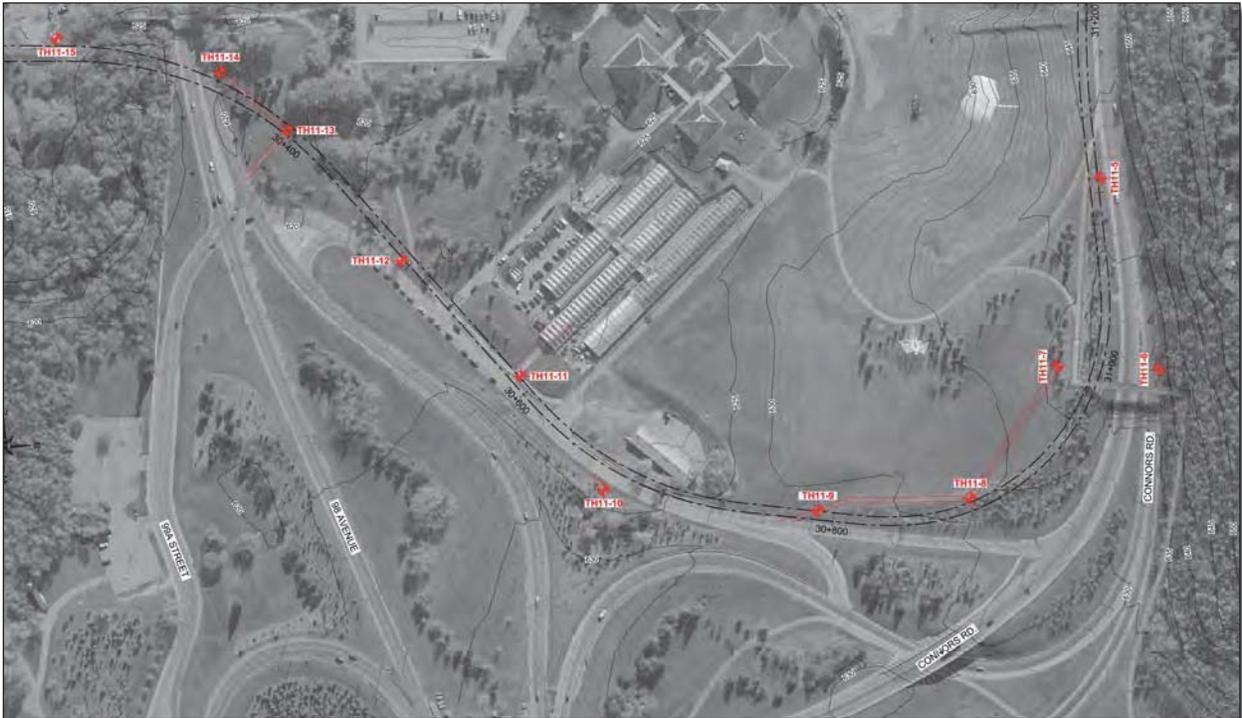
Figure 17. Geotechnical test hole drilling program locations showing south floodplain around Muttart Conservatory and topography of south valley slope along Connors Road. Courtesy AECOM.

The vertical clearance of the LRT bridge over the North Saskatchewan River has not been determined. The vertical clearance, however, will be set to meet the federal *Navigable Waters Protection Act* (Figs. 10, 19). On the south side of the North Saskatchewan River channel, the bridge-trackway will remain elevated across the pedestrian path and 98 Avenue, then continue to descend in elevation to near grade level at the proposed Muttart Station (Figs. 17, 19).

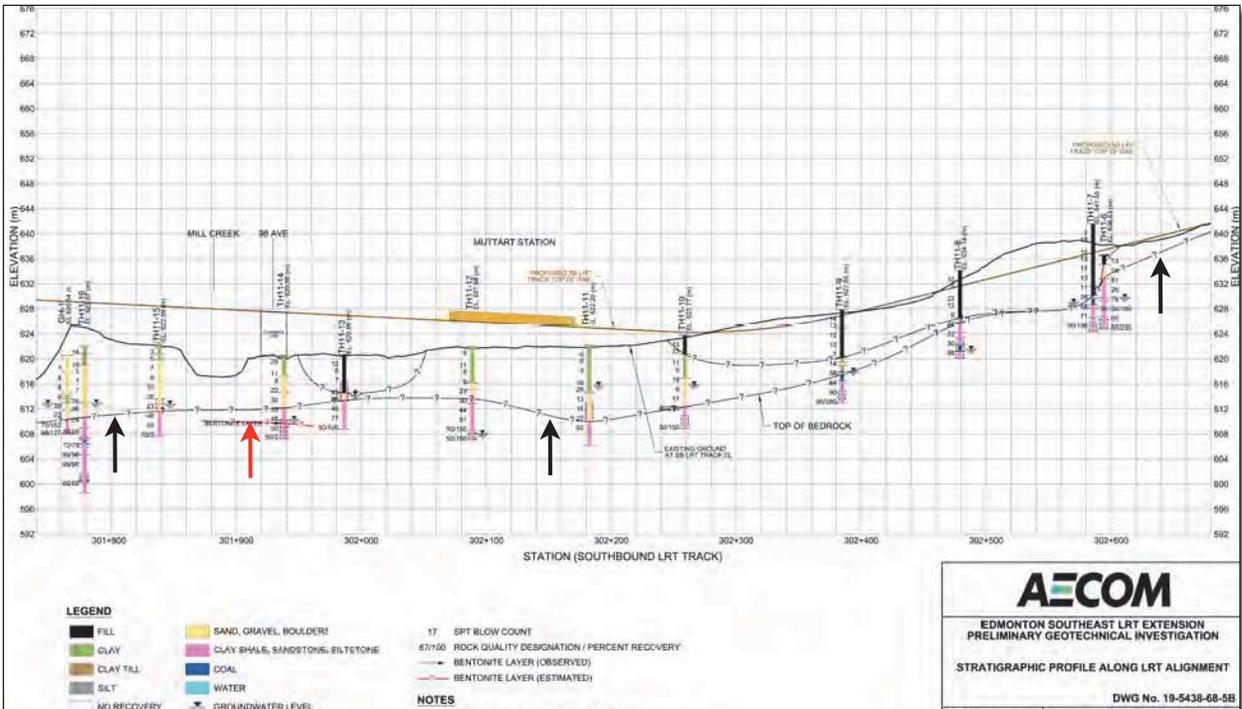
Figure 18. Stratigraphic profile along North Saskatchewan River and base of Connors Hill section of proposed LRT alignment. Drill hole locations TH11-7 to -16 shown. Note estimated top of bedrock (— ? —) (→) and bentonite layers (— ? —) (→). Courtesy AECOM.

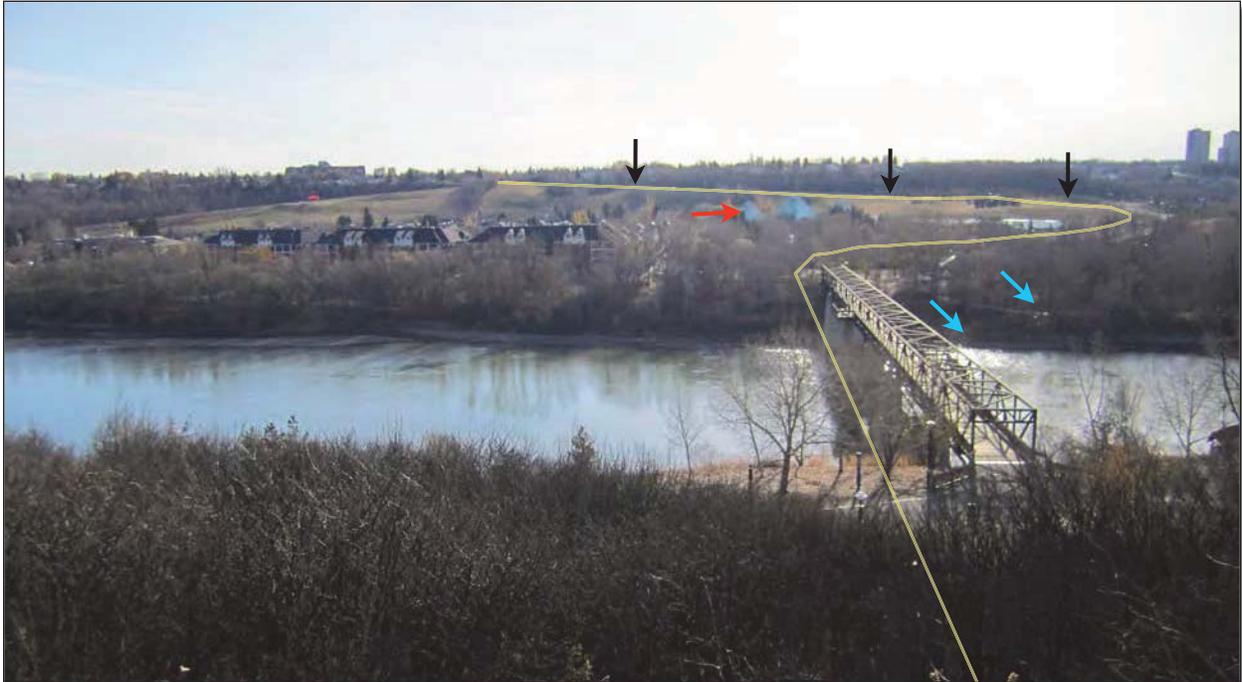
Figure 19. View facing south along proposed alignment (—) near tunnel portal on upper north slope of North Saskatchewan River Valley. View shows footbridge, gully on south bank (→), Muttart Conservatory pyramids (→) and Connors Road (→) in background.
