Appendix H. Historical Resources Reports

**HISTORICAL RESOURCES IMPACT ASSESSMENT
SOUTHEAST LRT ALIGNMENT
IN LSD 15-33-52-24-W4M
IN THE CITY OF EDMONTON**

FINAL REPORT ARCHAEOLOGY PERMIT 2011-249

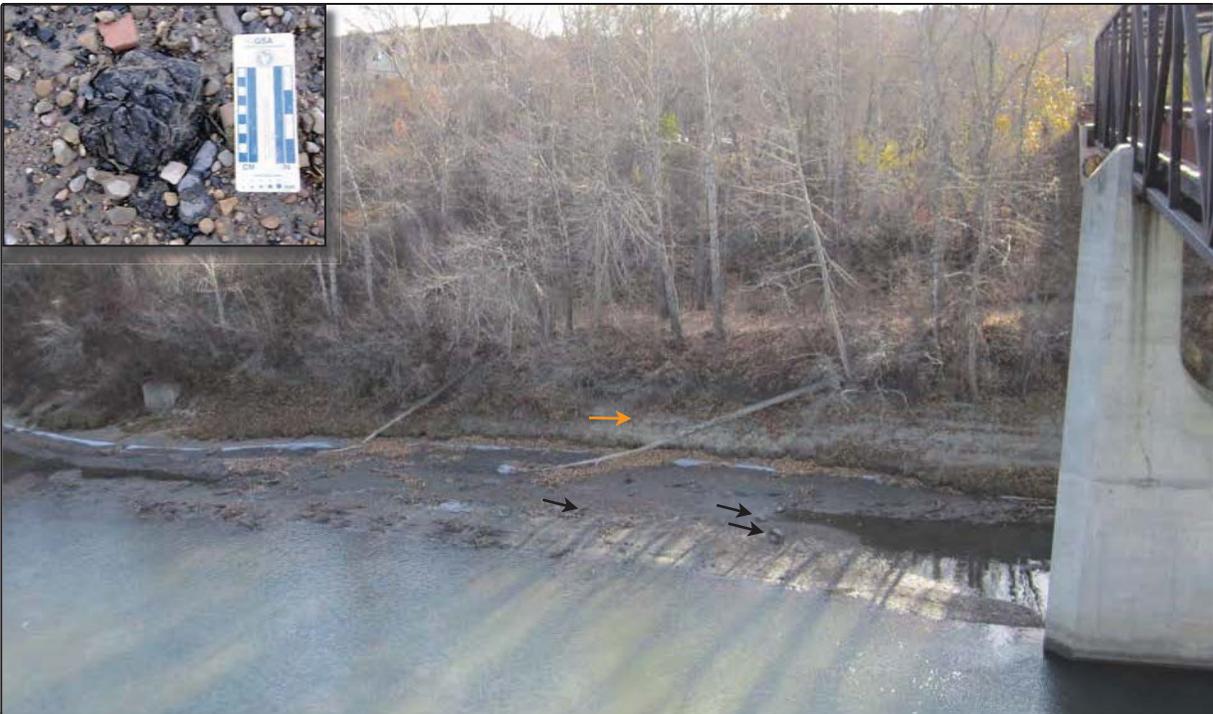
Figure 20. View looking southeast from footbridge observation deck showing exposed right (south) bank of North Saskatchewan River. Note thick floodplain deposits along bank (→) and reworked coal (inset) and bedrock fragments (→) along exposed river bed.

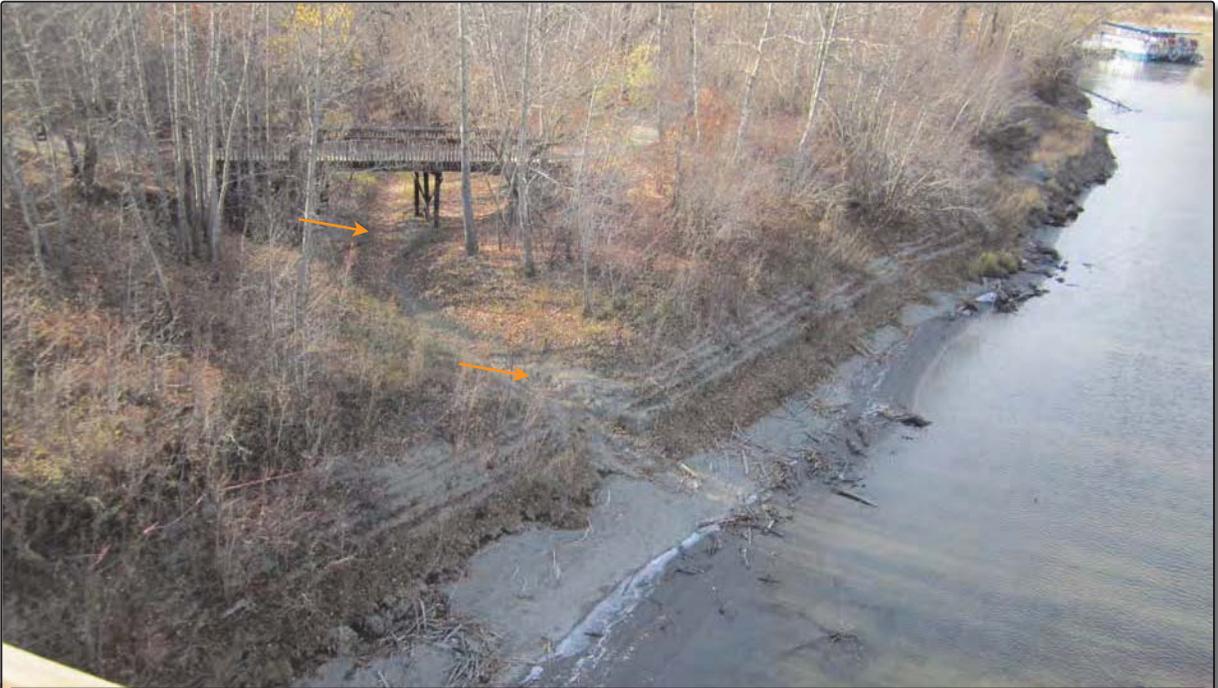
Figure 21. View facing southwest from footbridge showing gully (→) incised into thick floodplain deposits on the right bank (south side bank) of the river.

The pedestrian survey (at low water levels in the fall season) of the right (south) bank of the river, noted thick floodplain deposits of silt and fine-grained sands (Figs. 20-22). Due to low water levels in the fall, the river bed and gravel bar were also exposed and accessible. Numerous coal and reworked bedrock fragments from the Horseshoe Canyon Formation were noted among the coarse gravel deposits of the exposed river bed (Fig. 20). The stratigraphic cross sections provided indicate that the underlying bedrock lies close to the ground surface - anywhere from 0.5 to 2 m below the river bed (Fig. 10). Therefore, any pit excavations (open caisson - retaining, water-tight structures) in the river channel will have a potential to impact bedrock.

As the proposed elevated trackway continues south from the right river bank and associated levee to the proposed Muttart Station, it crosses the alluvial terrace (active floodplain/river-built terrace) (Fig. 23). The unconsolidated deposits on the alluvial terraces average 10 m in thickness, with the deposits thinning to approximately 5 m along the dry stream bed of the gully (gully = original Mill Creek Ravine outlet channel) that has incised into the floodplain (Figs. 18, 19). Based upon the site survey and utilizing information from a 2008 Thurber geotechnical report (North Western Utilities project), the alluvial deposits are comprised of clay-silt, sand and gravel deposits (in descending order) (Figs. 21, 22).

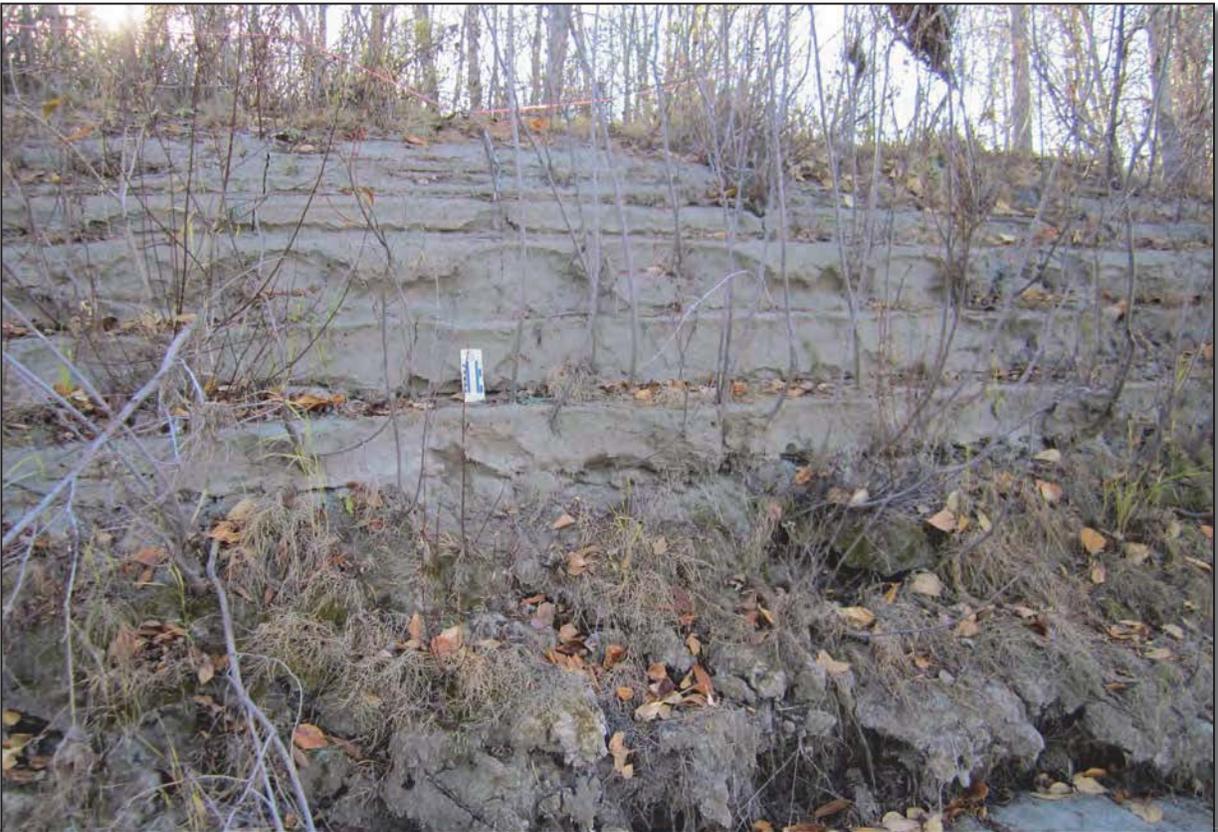
Figure 22. View of right bank from river level showing thick floodplain deposits of silt and sand next to mouth of gully (→) in Figure 21. White scale bar sheet = 15 cm high.

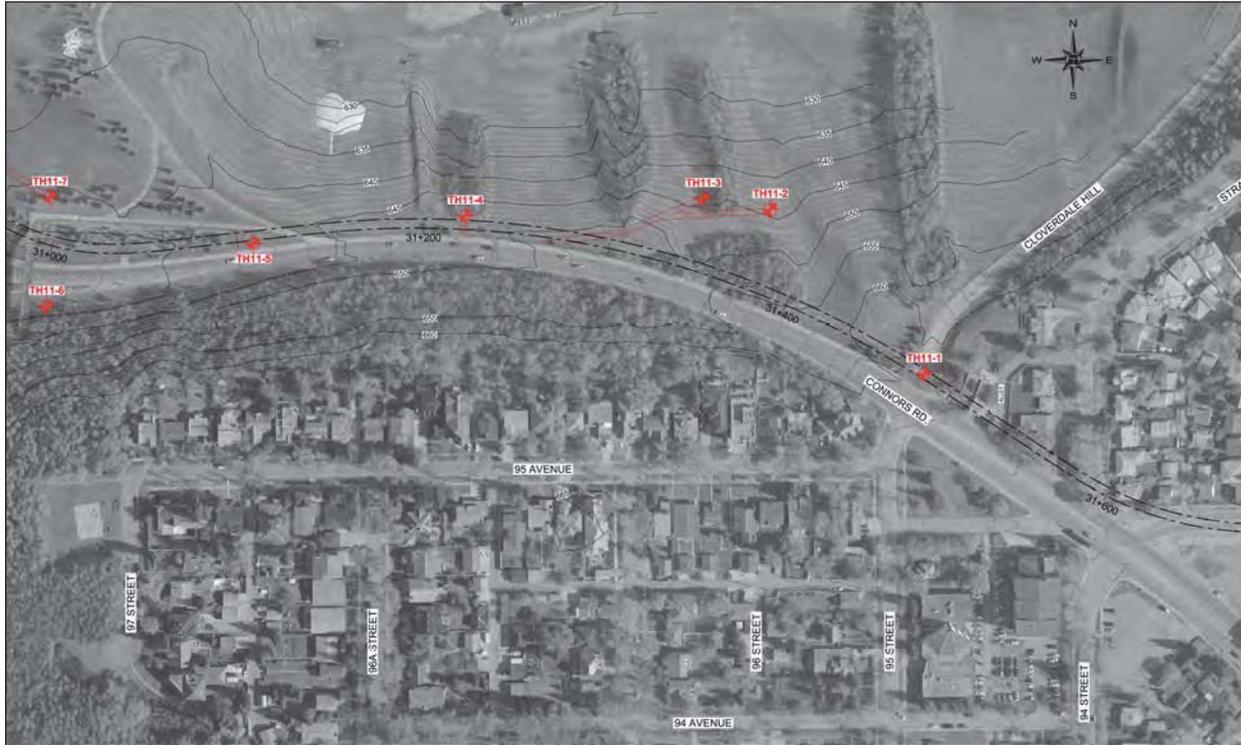
Figure 25. Geotechnical test hole drilling program locations showing topography of south valley slope along Connors Road. Courtesy AECOM.

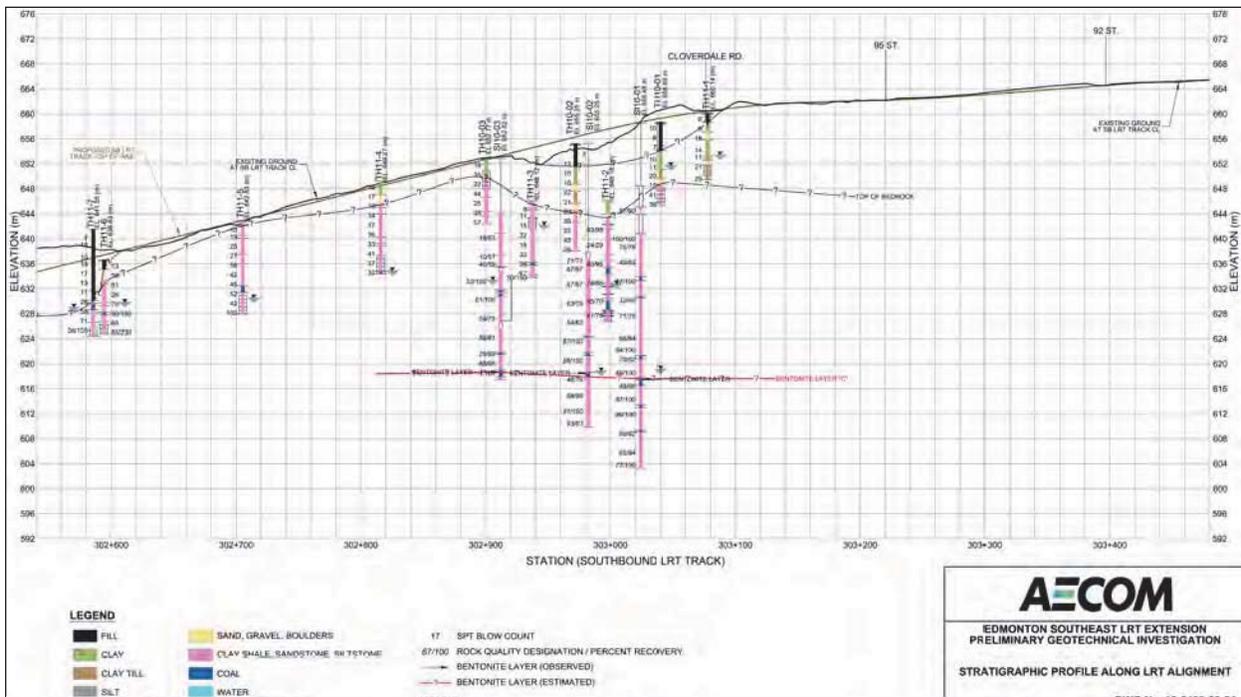
Figure 26. Stratigraphic profile along Connors Hill section of proposed LRT alignment. Drill hole locations TH11-1 to -7 shown. Note estimated top of bedrock (---)(-) and bentonite layers (-?-)(-). Courtesy AECOM.

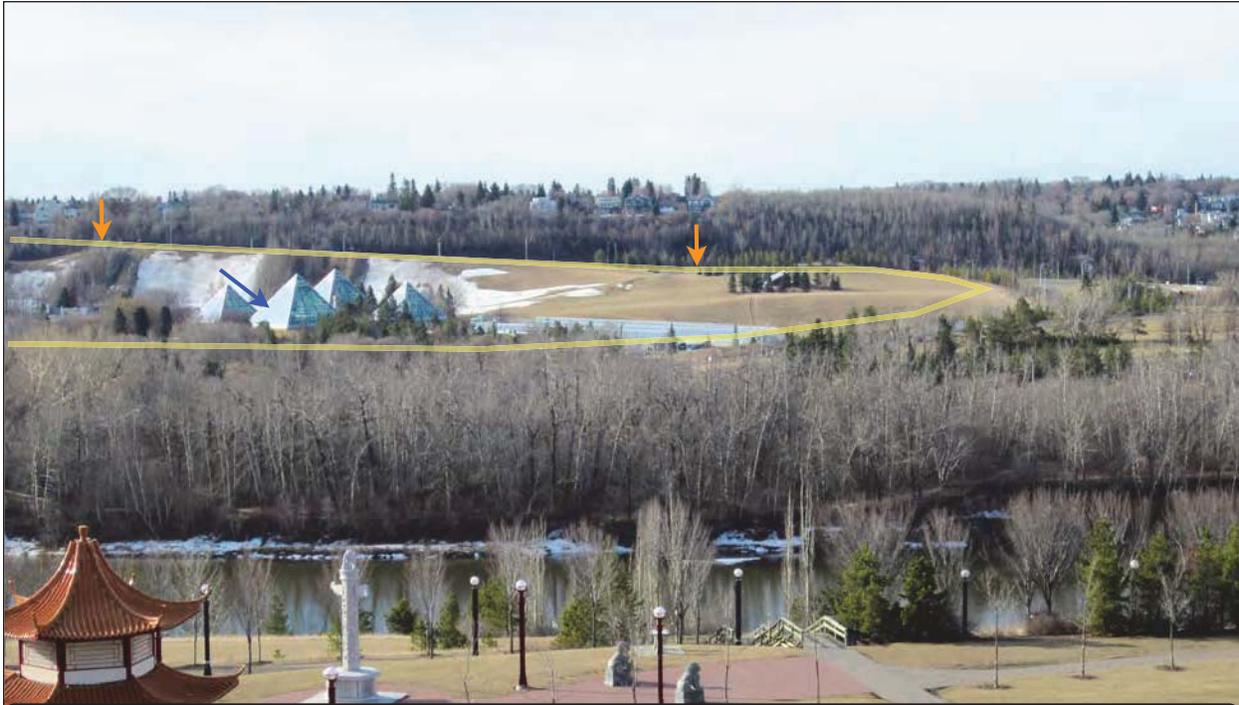
Figure 27. View looking south from top of north valley slope showing Muttart Conservatory pyramids (→), Connors Road (→) and proposed LRT alignment (—). Area between orange arrows (→) is area that bedrock is close to the surface.

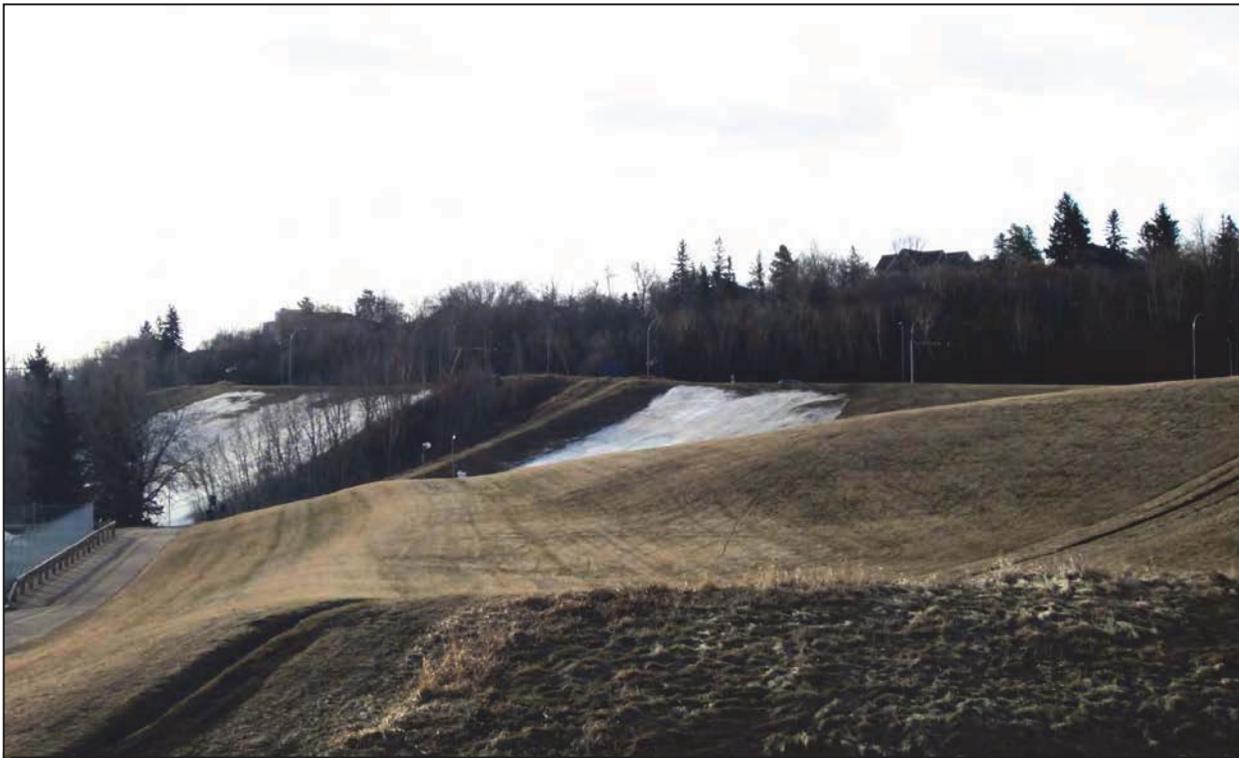
Figure 28. View looking southeast below Connors Road showing moderate to steep landscaped slopes along the middle valley slope. Area of thin cover over bedrock.

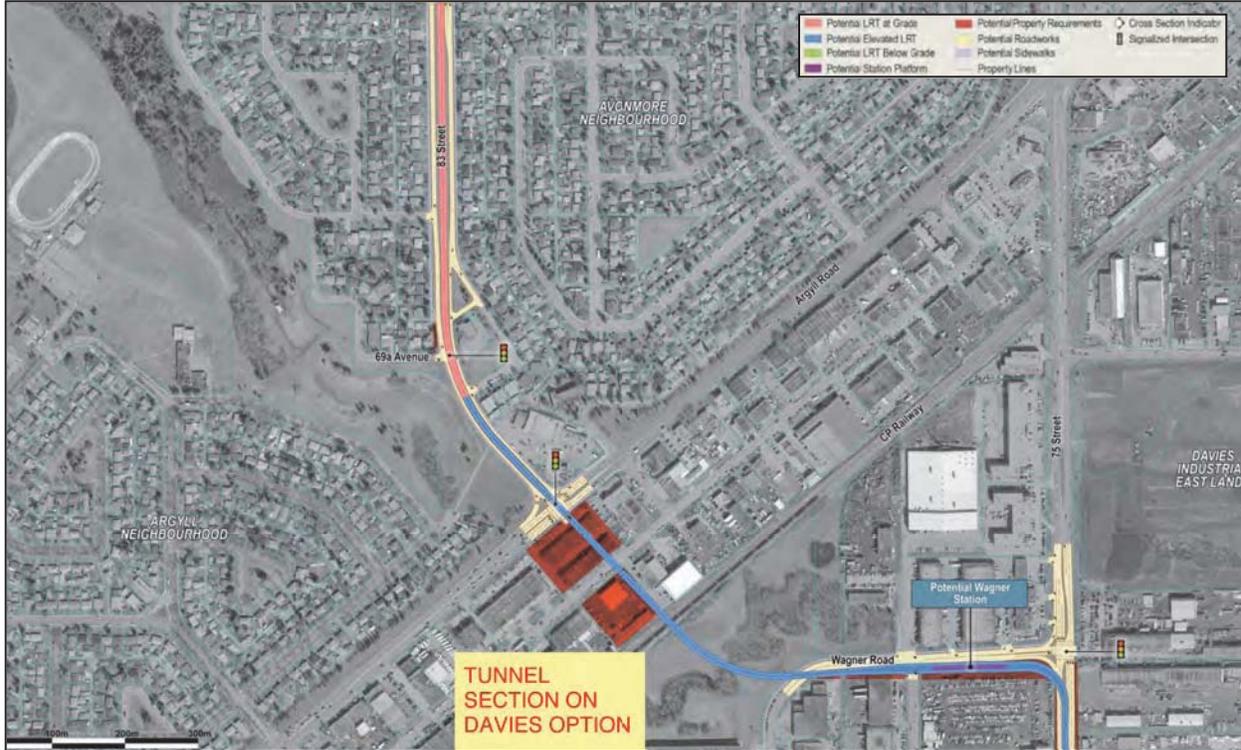
Figure 29. Photomosaic of proposed Argyll Road-Wagner Road alignment showing elevated trackway crossing Argyll Road, CN railway, and Wagner Park. City of Edmonton.

The author noted that the proposed SE LRT alignment called for an elevated trackway across Argyll Road, Wagner Park and along Wagner Road. The optional Davies Road alignment along with the below ground tunnel have been removed as a potential option (Figs. 29-31). Although there were no HRV notations for paleontology assigned to the area (Fig. 5), a brief pedestrian survey of the dry creek bed and banks within Wagner Park was undertaken. The survey was undertaken as the creek in Wagner Park is part of the original Mill Creek Ravine drainage system (Figs. 2, 3).

The proposed trackway will be elevated over Argyll Road and Wagner Park and return to grade near the intersection of Wagner Road and Davies Road (Fig. 29). Foundation support structures for the elevated trackway along this corridor will likely be pre-drilled and/or driven piles. The possible maximum pile length will be 26 m. Typically, there is no potential of recovering paleontological resources from driven piles. However, there is a low to moderate potential of recovering intact paleontological resources from borehole drillings/spoil material (see page 21). Overall, there is a low potential that grading, ground surface preparation and construction of foundation supports will disturb bedrock due to the depth that bedrock lies below ground surface (greater than 13 m).

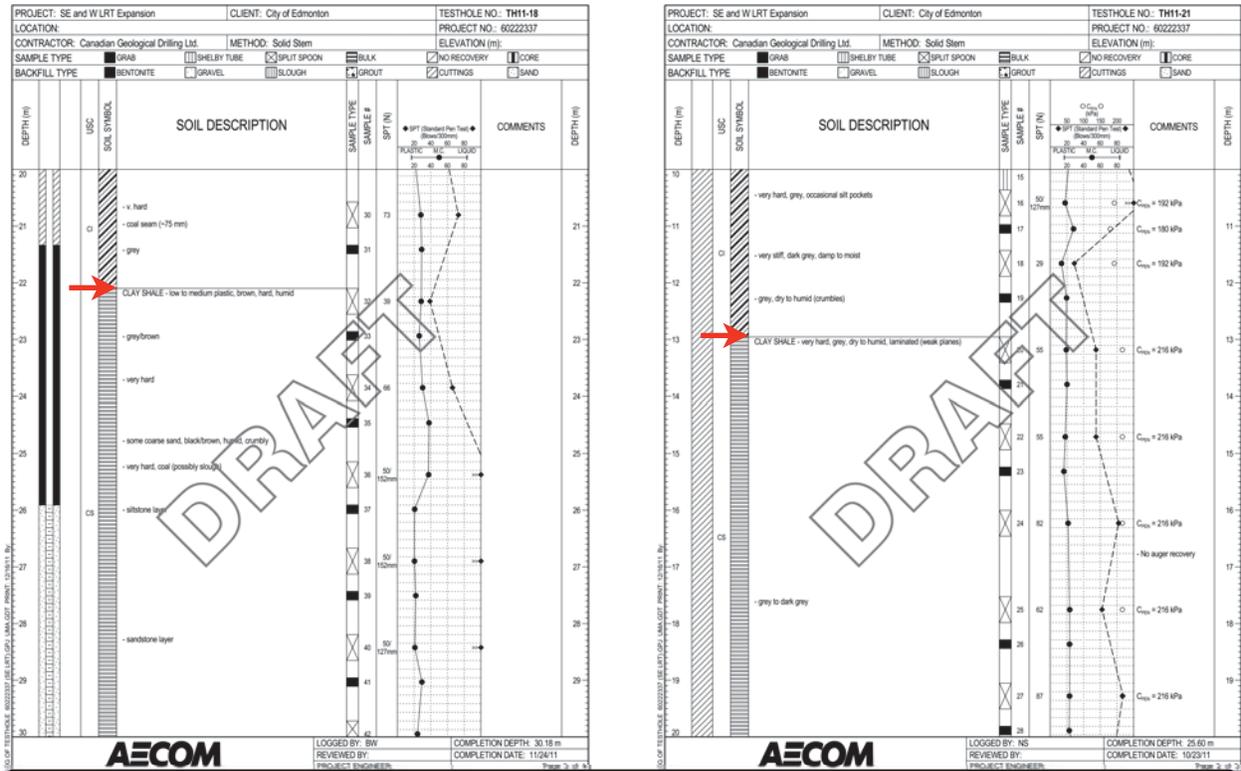
Figure 32. Portion of drill test hole logs from TH11-18 and 21 (see Fig. 30) showing bedrock contact (→ = start of clay shales from Horseshoe Canyon Fm.). Courtesy AECOM.

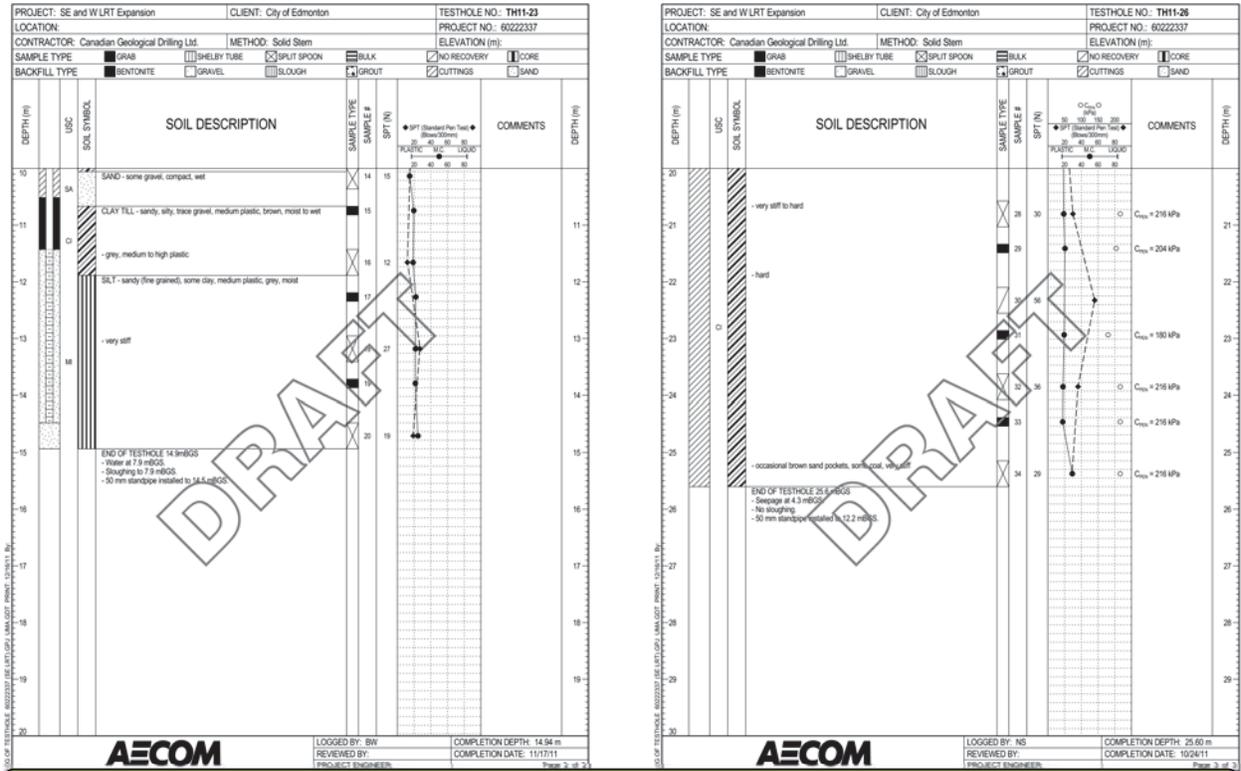
Figure 33. Portion of drill test hole logs from TH11-23 and 26 showing (see Fig. 30) end of test hole in 'Quaternary' deposits. No bedrock contact logged. Courtesy AECOM.

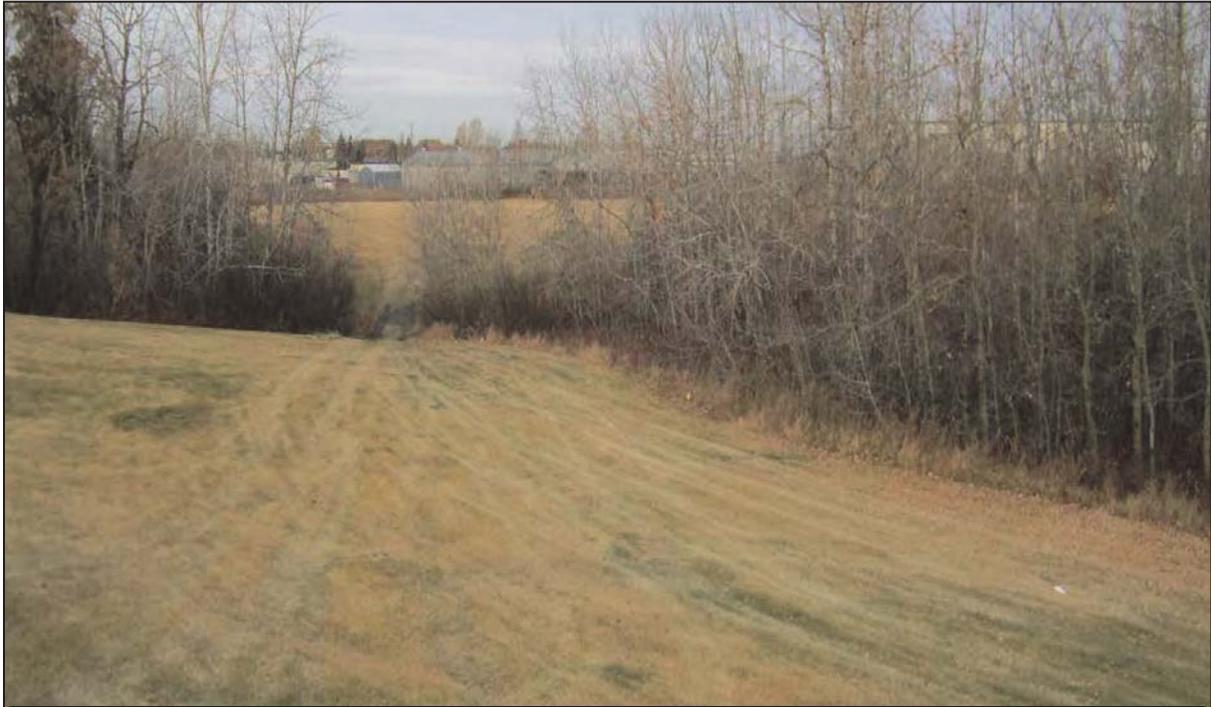
Figure 34. View facing northwest from south side of Wagner Park along proposed alignment showing thick vegetation surrounding dry drainage. The drainage is an isolated section of the original Mill Creek drainage system maintained within the park.

Today, the isolated section of Mill Creek in Wagner Park is bounded by city infrastructure (roads and commercial development) (Fig. 30). The park has been landscaped along the proposed ROW except at the crossing. The creek channel and a small riparian buffer around the channel remains intact and is vegetated with shrubs and trees (Fig. 34).

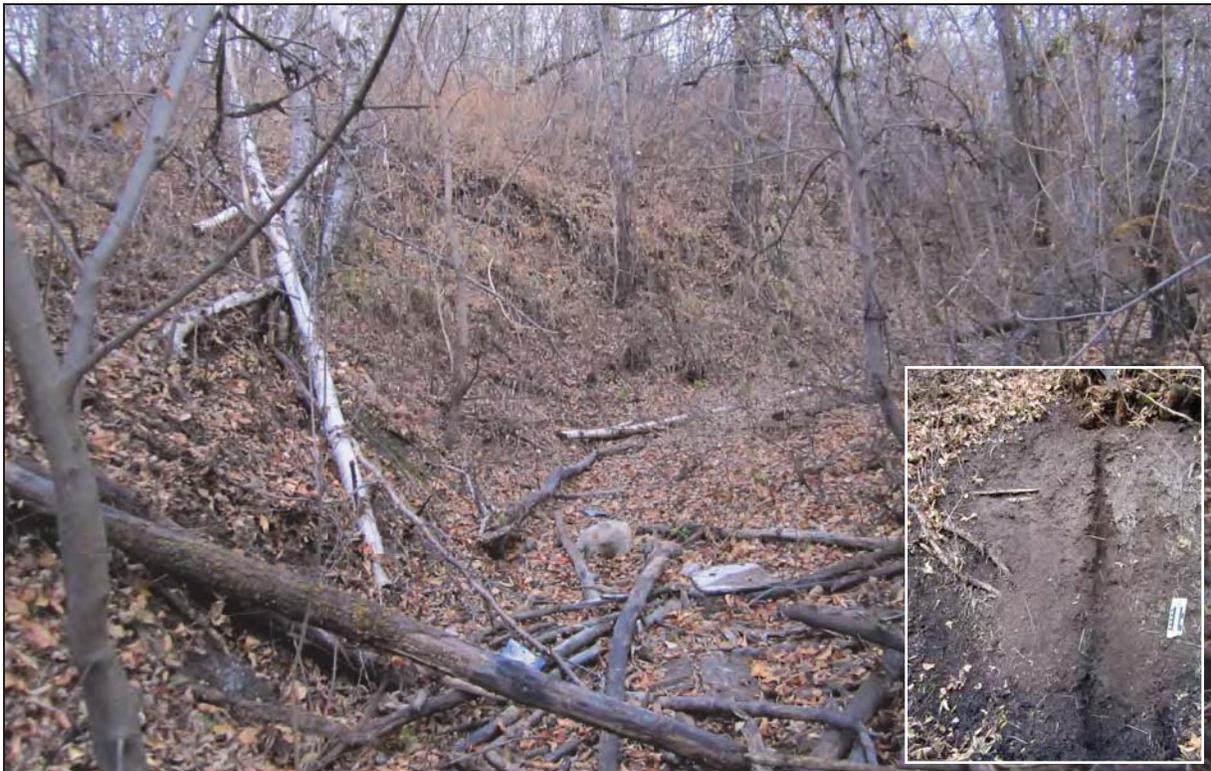
Figure 35. View facing north from dry creek bed in Wagner Park. Inset shows thick deposits of clay till (silt and silty sand) along banks of dry creek bed (aka Mill Creek).

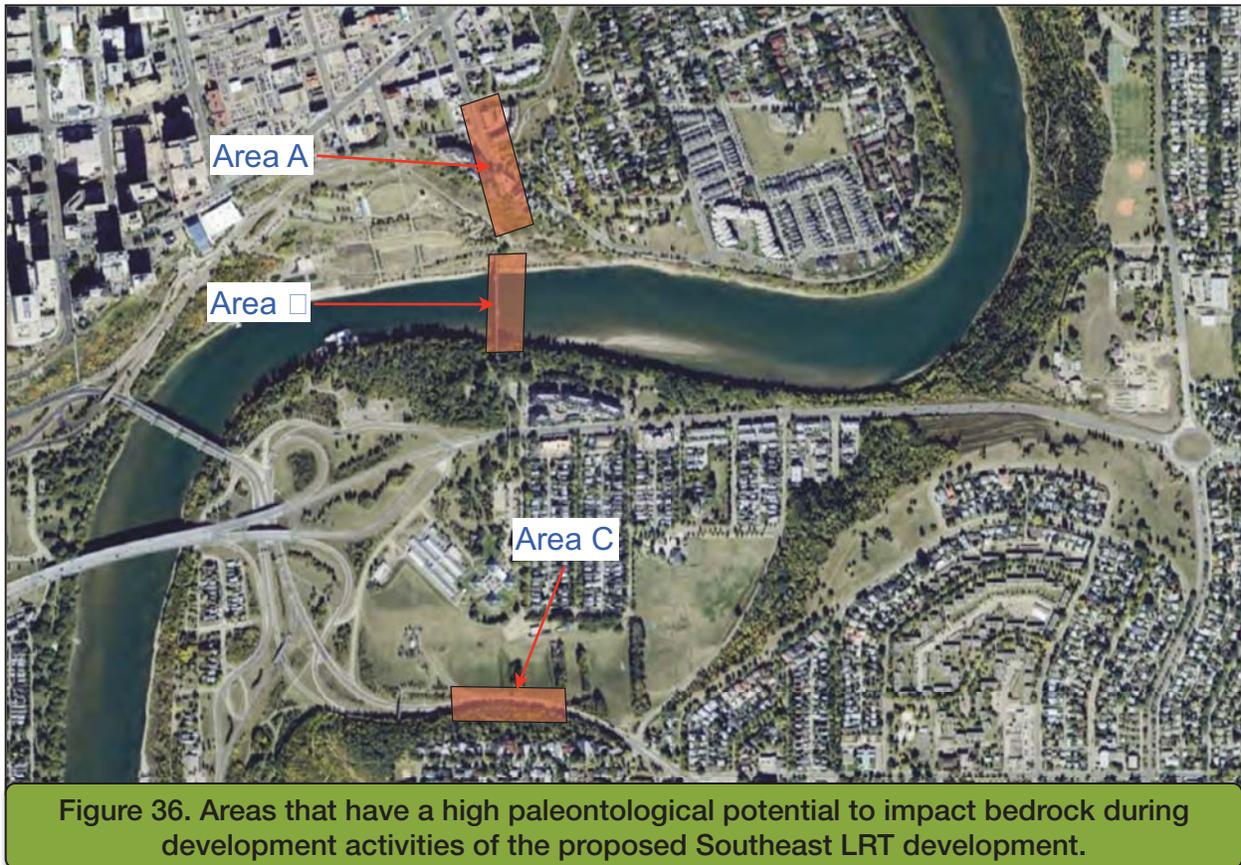
The Historic Resources Management Branch of Alberta Culture and Community Spirit issued a Schedule A requirement for paleontology for the Southeast LRT Planning Study (ACCS File: 4715-10-042). After completing the pre-construction Historic Resources Impact Assessment for paleontology, background research, discussions with staff at AECOM and Thurber Engineering, and a review of the drill hole logs and stratigraphic cross sections, three areas of high paleontological potential were noted for the currently proposed SE LRT alignment (**Fig. 36**).

Based primarily upon the bedrock geology, stratigraphic cross sections and construction techniques likely to be utilized during development, it is suggested that these three areas (Fig. 36) require a paleontological monitoring program (Table 3), as there is a high potential to disturb significant fossil resources from the Horseshoe Canyon Formation. Horseshoe Canyon Formation deposits in this area are known to contain the well-preserved fossil remains of large vertebrates (primarily dinosaurs) - both dinosaur bone beds and isolated remains have been recovered from the slopes and the floodplains of the North Saskatchewan River Valley and its major tributaries within the City of Edmonton. This includes dinosaur bone fragments from Mill Creek Ravine and the valley slope at the Quesnell Bridge. Therefore, any significant amount of disturbance of these bedrock sediments is considered to have a high potential to disturb fossil resources.
